Restoration of Cleveland Bridge in Bath: Work Undertaken by Dorothea Restorations Limited

Geoff Wallis and A. Wilkinson

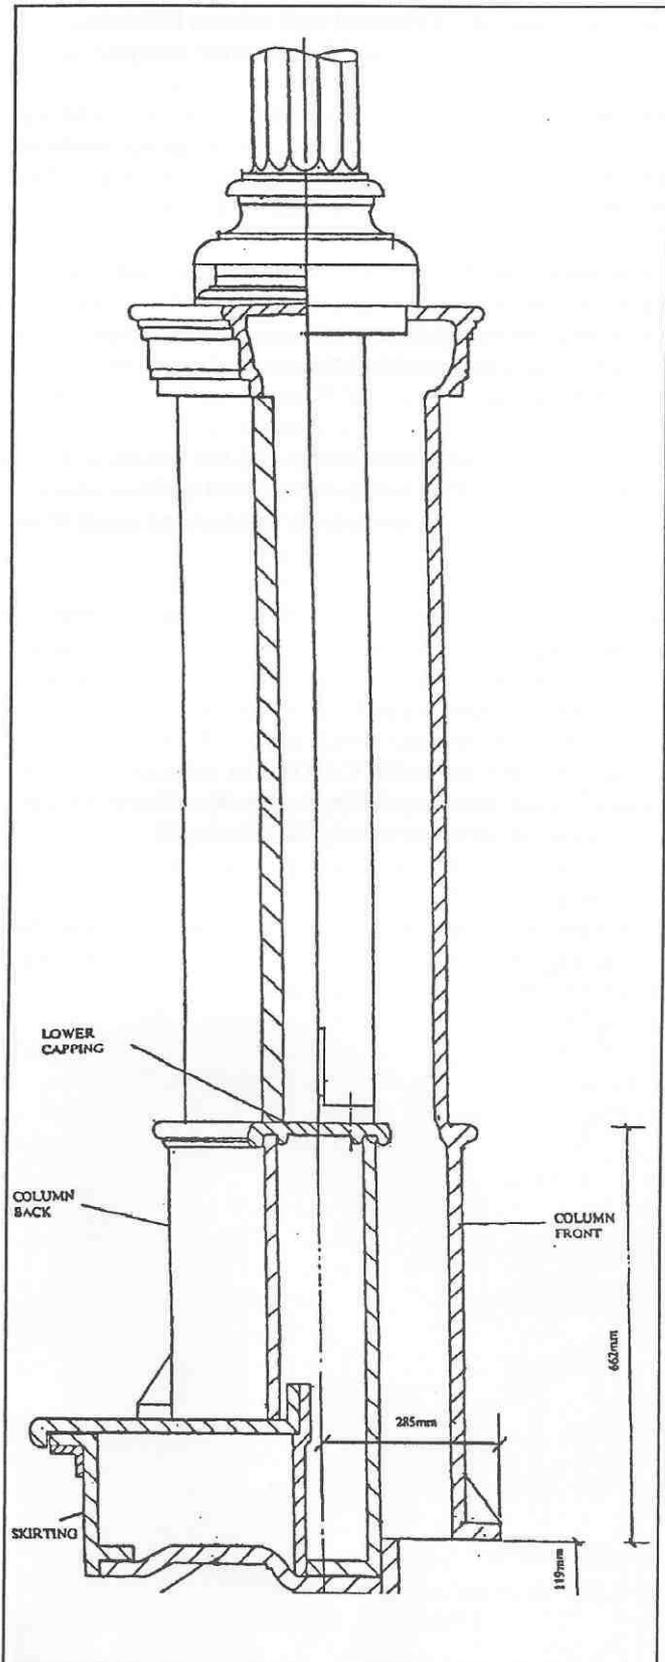
Section through part of bridge parapet, Dorothea Restorations Ltd., April 1992.

Castings were generally repaired by mild steel plates bolted onto the inside face of the assembly, making repairs undetectable from the outside. Plates were painted and bed-

ded onto broken castings with epoxy resin filler to prevent future water ingress.

On the decorative balustrade-castings additional structural fixings were provided to upgrade strength to modern requirements.

Reconstruction then started on site. First large inner backplates and ribplates were mounted onto a previously erected stainless steel angle. Once they were all in place, holes were drilled through the steel, and tapered washers, nuts and bolts fitted. Contact between the original iron and the stainless steel was avoided by use of rubber shims to preclude dissimilar-metal corrosion. All bolts were zinc plated.
