The Chimney in Milk Street, Bath

Mike Chapman

The Chimney and the Site

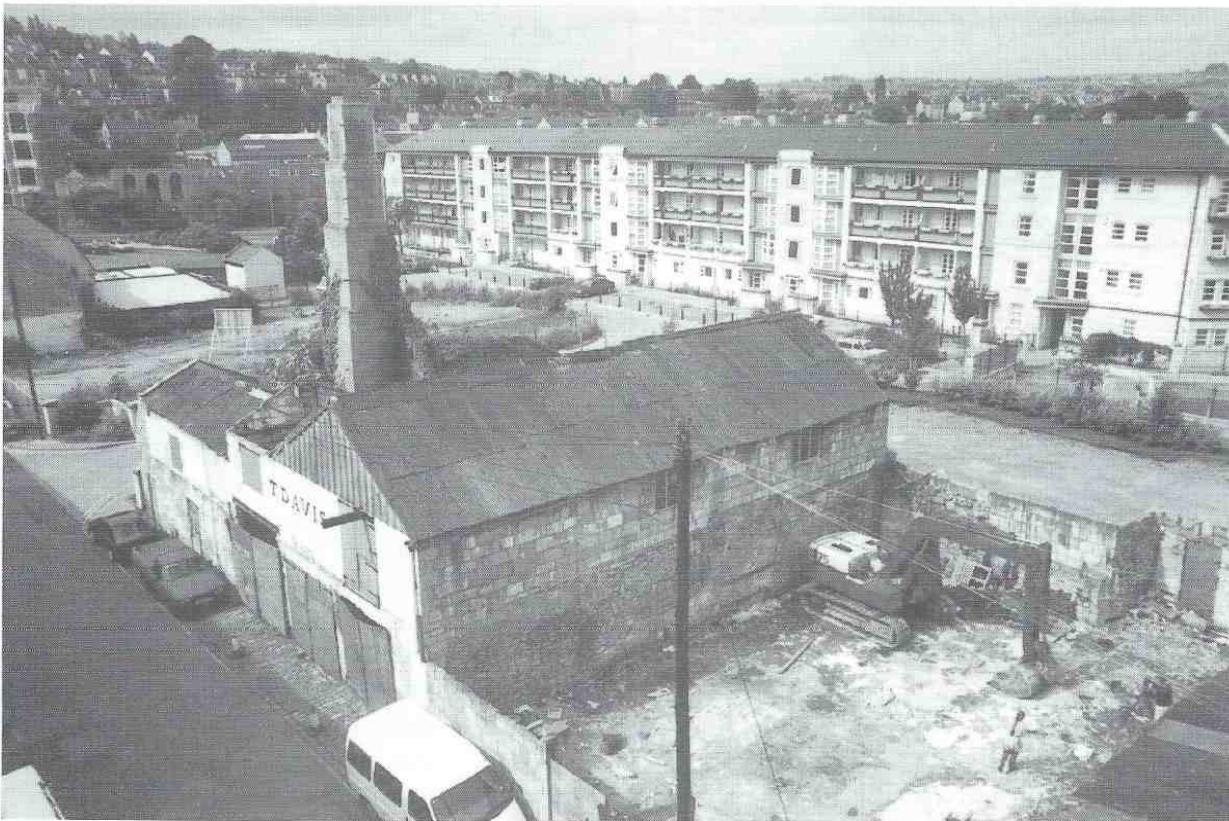
Milk Street Chimney and surrounding buildings, 2 June 1994

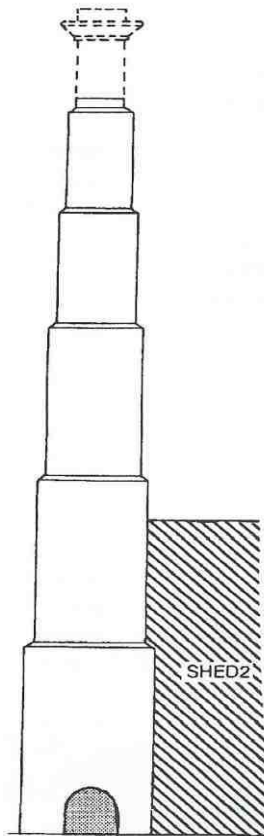
North elevation of chimney showing probable design of missing section

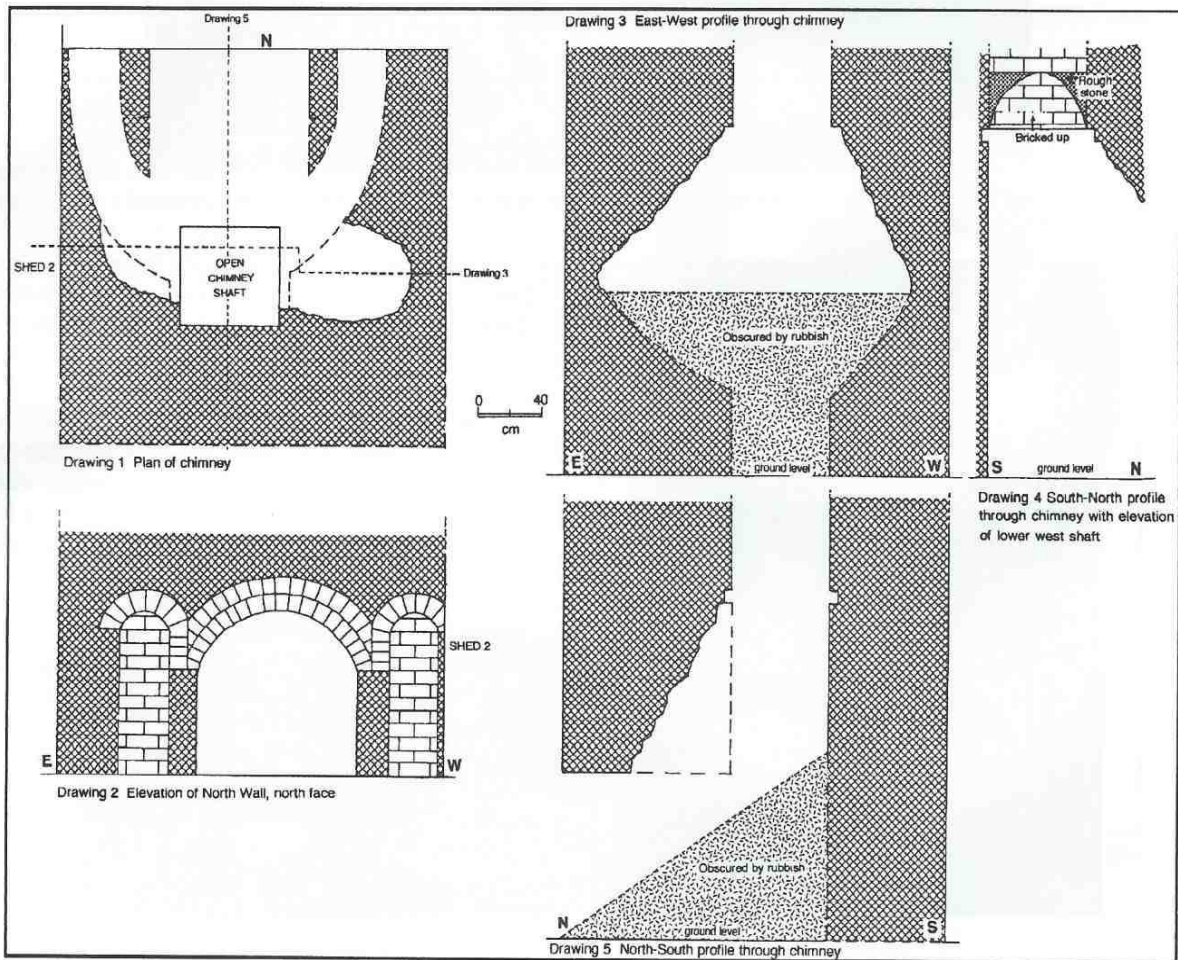
Internally it had a continuous square-section shaft, 50cm across, which started c2.1 m above the current yard level. Below this point there is a groove 5cm deep and 8cm high, running around the inside of the shaft (drawings 3,4,5). Above this groove there was a small arched opening on the west face, the full width of the shaft, then bricked up (drawing 4). The south face of the shaft continued to ground level, as far as could be seen because of debris. This was probably also the case with the east and west faces originally, but these had at some time been roughly hacked away to-

wards the outside of the chimney, leaving only 20-25cm between the inside and outside faces of the stack (drawing 3)² The flue entrances were to the north side of the chimney. There were originally three vaulted openings, consisting of a large 1 m wide off-centre opening flanked by two narrow ones 30 cm wide and now bricked up, all approximately 1 m high to the underside of the arch. The central opening led straight to the shaft, while the two outer ones curved inwards to join it. From the outer face inwards, approximately 40 cm survived of the vaults, beyond which they have been hacked away upwards towards the ledge (drawings 1 & 2). There was no sign of any machimney or boiler fixings.

Plan, elevation and profiles of Milk Street Chimney

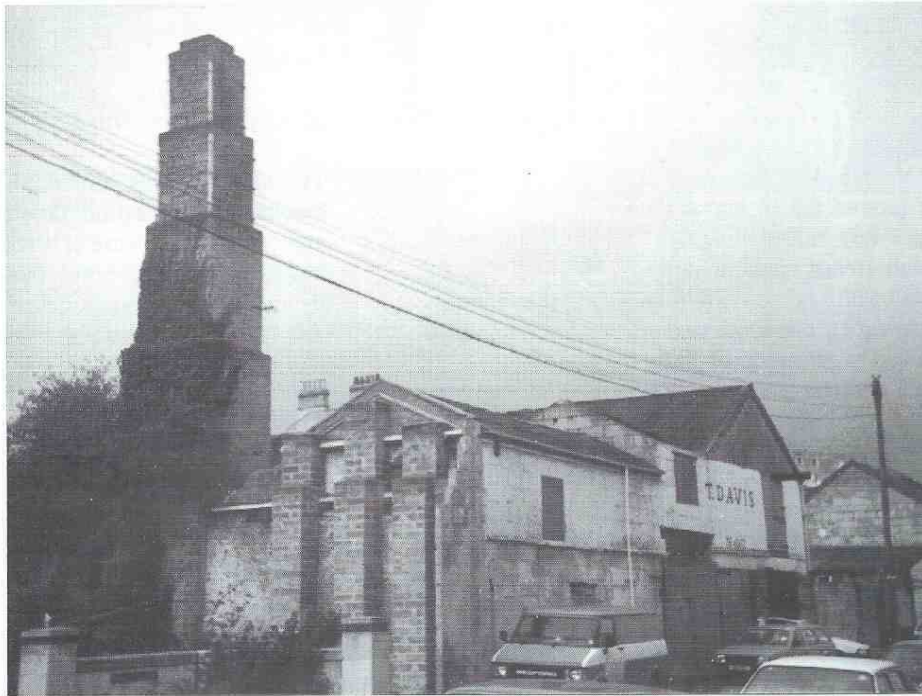
Milk Street Chimney viewed from the south east, 21 March 1994 (Photo Marek Lewcun)

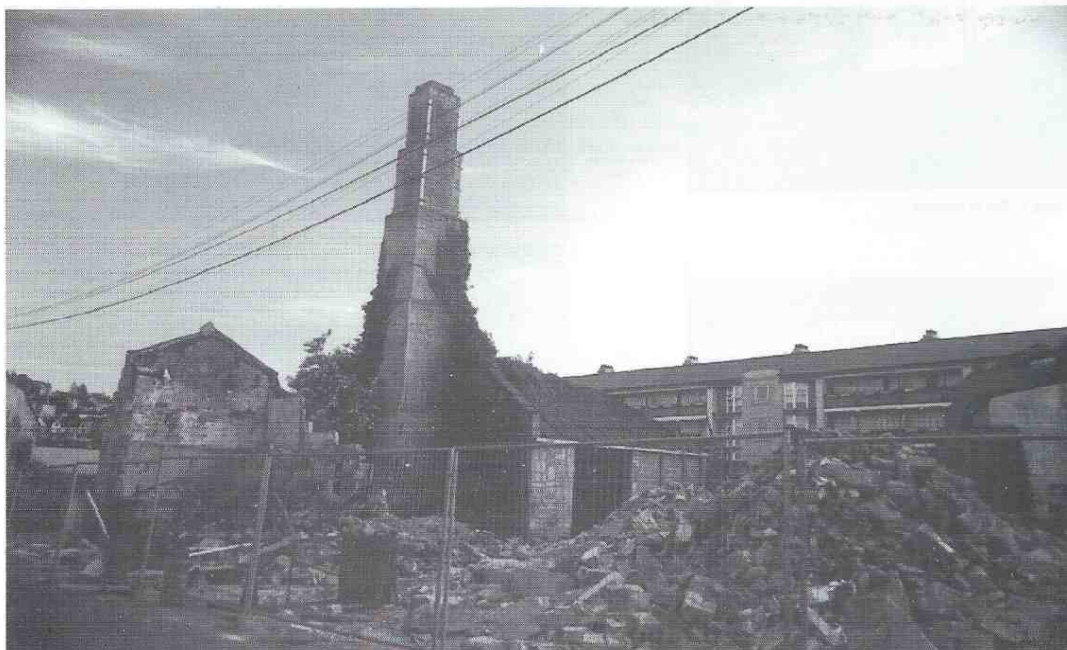
Milk Street Chimney viewed from the south west, 15 June 1994 (Photo Marek Lewcun)
