## Revelations at Great Elm

James Fussell

### Description of the excavation and adjacent area at 13 February 2000

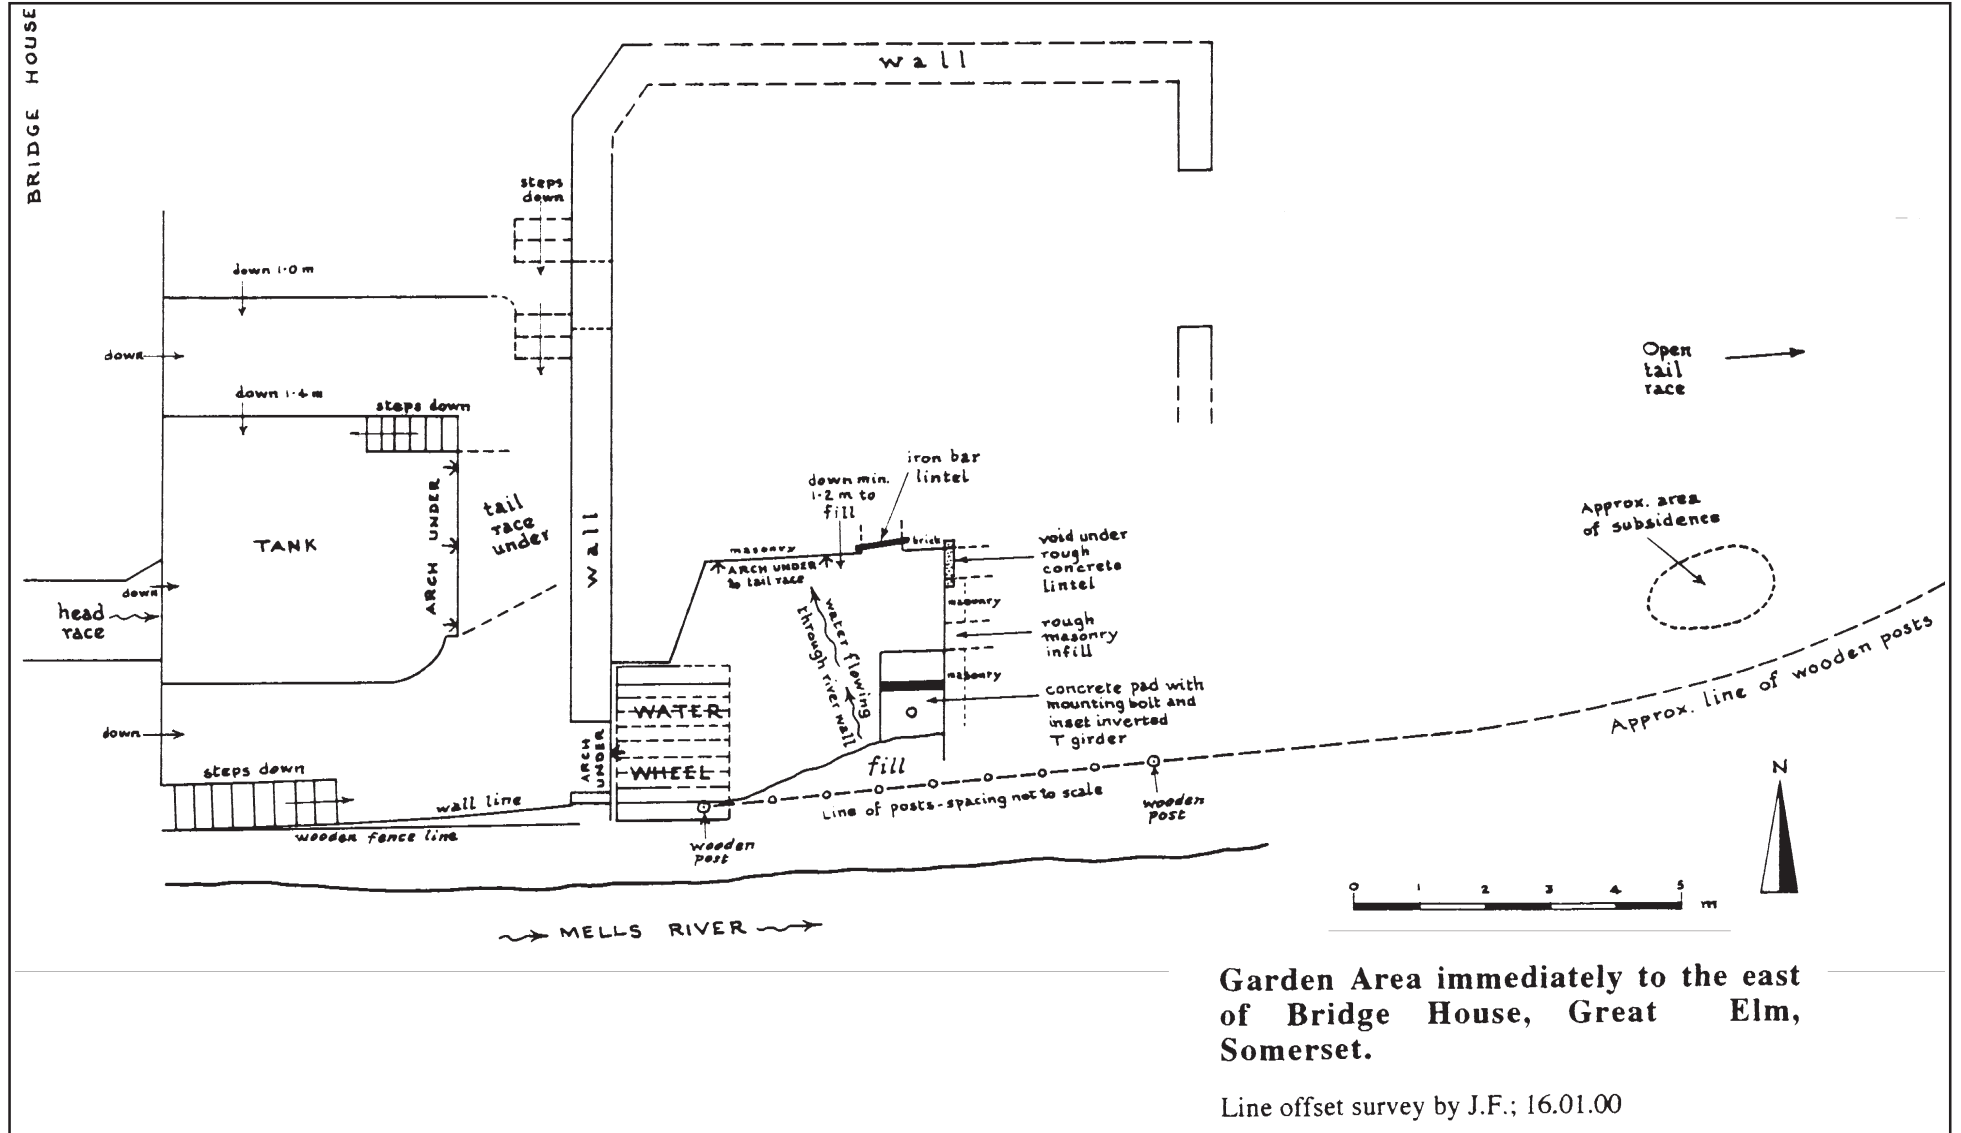
Fig 2 Site plan of the excavation at Great Elm, Mells

On the 13th January 2000 I visited the site again to make a sketch survey based on line offset measurements (fig 2). Shortly after this Mrs Wishart and I met Penny Stokes of Mendip District Council, who expressed considerable interest in the Great Elm site both on its own account and in the context of the whole Mells Valley and surrounding area industrial complex. We were looking at possibilities for funding further work but there is unlikely to be any funding available directly from Mendip.

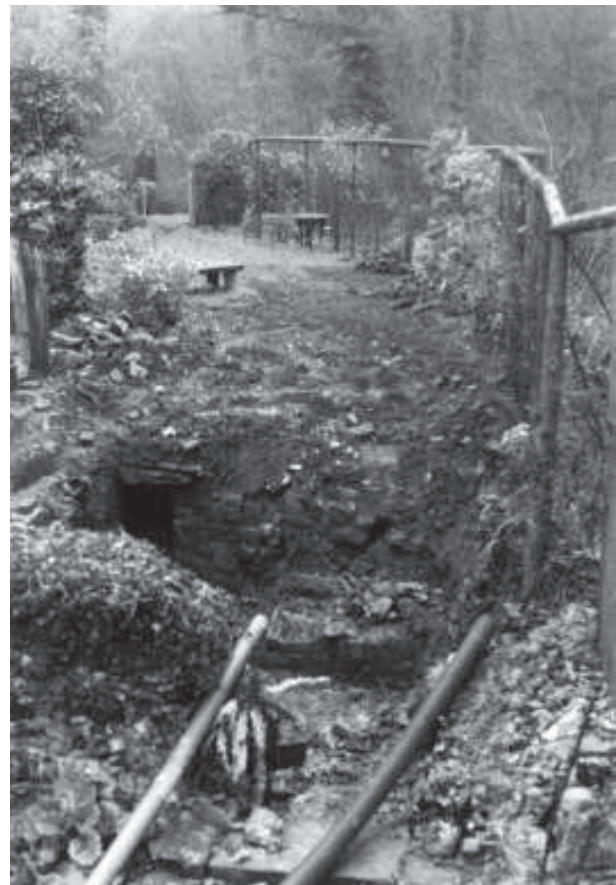
Plate 1 General view of the excavation looking east

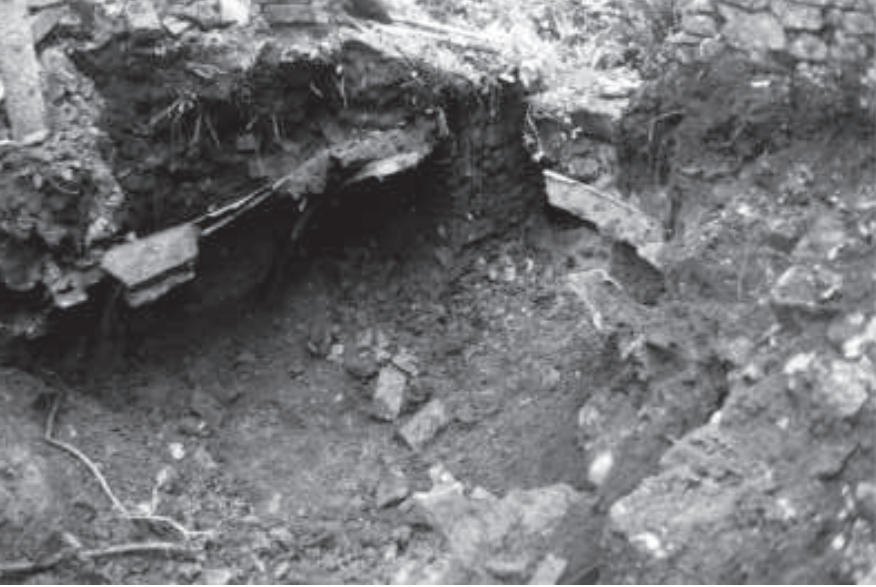
Plate 2 The remains of the waterwheel in the south west corner of the excavation

The waterwheel is obviously the first item to demand attention. Approximately 2.3m in diameter and 1.7m wide, it has cast iron sectional framing, the top sections of which have been broken off and are not visible. They may be present beneath the silt and rubble which still fills most of the bottom half of the wheel. The same observation applies to the missing radial spokes. The wheel has a wrought iron plate skin to which very steeply angled buckets are riveted. These are badly damaged in the part which is exposed at the moment but looking down at both sides the rest of them seem to be in relatively good condition. There is a void, albeit a fairly narrow one, between the wheel and the fill adjacent to the river wall with running water at the bottom. Where the wheel abuts onto masonry walls the clearance is very small, of the order of 2cm.

Running through the central axis of the wheel and sloping down to the east is a massive baulk of timber. This is some 0.5m square in section at the western end and at least 3m long. It has a large slot cut into one side at the mid point of the wheel and seems to have snapped immediately to the east of this. There are signs of possible charring on this timber although this has yet to be confirmed. First thoughts were that the timber was a large beam which had fallen from the roof of a room constructed above the wheel pit, possibly during a fire, and broken through the top of the wheel as it fell. There are difficulties with this scenario, not least of which is that the western end of the timber baulk is well *under* the top of the second wheel mentioned in the following paragraph. It is difficult to imagine the timber having been moved in view of its undoubted weight but the wheel, or part of it, may have been moved over the timber.

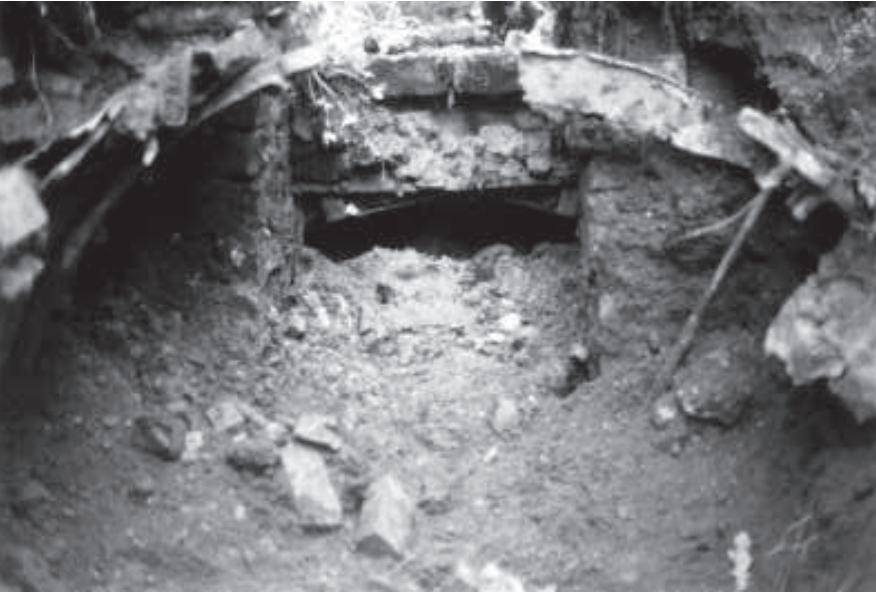
Plate 3 View through the waterwheel showing the second wheel beneath the arch

wheel alongside it immediately to the east, although this is *almost* pure speculation at present. However, there *is* another wheel immediately to the west, with the top forming the support for the low arch which can be seen in plate 3. This wheel is not fully accessible as yet. The geometry of its position and the adjacent masonry means that it cannot be *in situ*; it is possible that only the top section is present and that it was moved to its present position simply to provide support for the arch. However, it is unlikely to have been moved far.

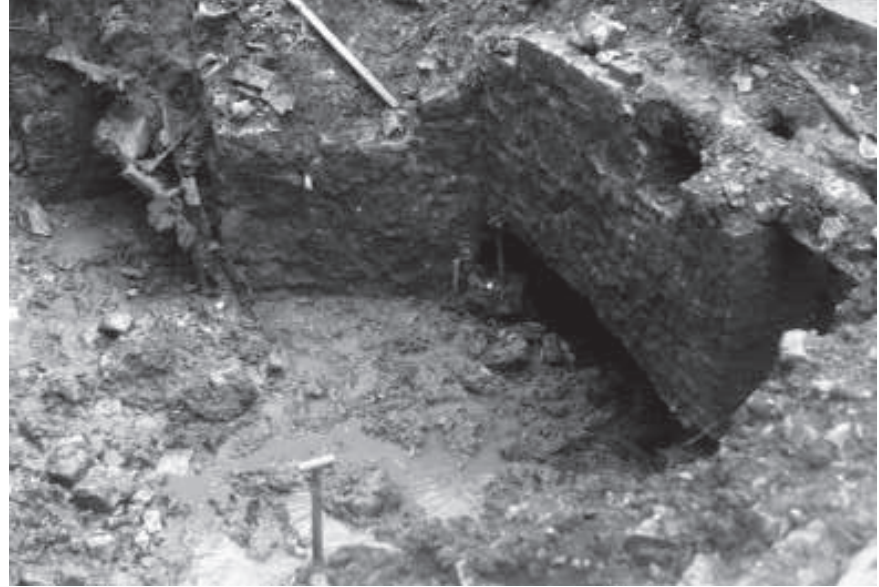
Plate 4 Masonry arch leading to the tail race on the north side

Within the current excavation a number of features are visible although none have been satisfactorily explained as yet. In the interests of stability, no attempt has been made to cut back to the river wall. The northern wall of the excavation is mainly of masonry construction over the flat arched opening leading to the tail race. What appears to be a small water channel leads off to the west under the western end of the arch. A small slot is cut back into the wall near the top above the eastern end of the arch. To the east of the arch there is a 0.6m gap within which a corroded vertical iron plate holds back loose fill material. The gap is bridged by a thick iron strip lintel with mortared rubble on top of it. Both sides of the gap are formed of brickwork and this material also forms the structure of the wall to the east of the gap which extends into a spoil choked 0.5m wide slot between it and the eastern wall of the excavation, the gap being bridged by a rough concrete lintel.

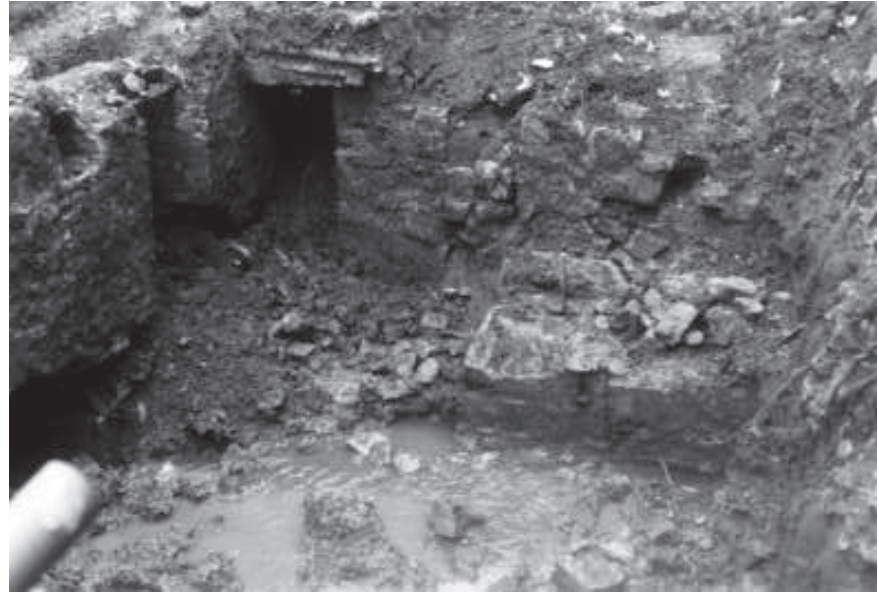
Plate 5 Masonry structures on the eastern wall of the excavation

The eastern wall is again of masonry construction. After some 0.6m there is another 0.4m slot, this one being filled with rough masonry. The masonry wall then continues into the fill adjoining the river wall, though the masonry construction is breaking down before it reaches the fill. There is a masonry pad on the floor of the south eastern corner of the excavation, butting onto the eastern wall. Bedded into the top of this are a length of J section girder and at least one large mounting bolt. A copious flow of water resurges from beneath the corner of the pad nearest the river and this is clearly the leak through the river wall which instigated the original collapse.

In addition to investigation of the ironworks, remedial work will have to be carried out on the river wall, leakage through this wall being the initial cause
