BIAS EXCAVATION at KINGS MILL

by Owen Ward & John Cornwell

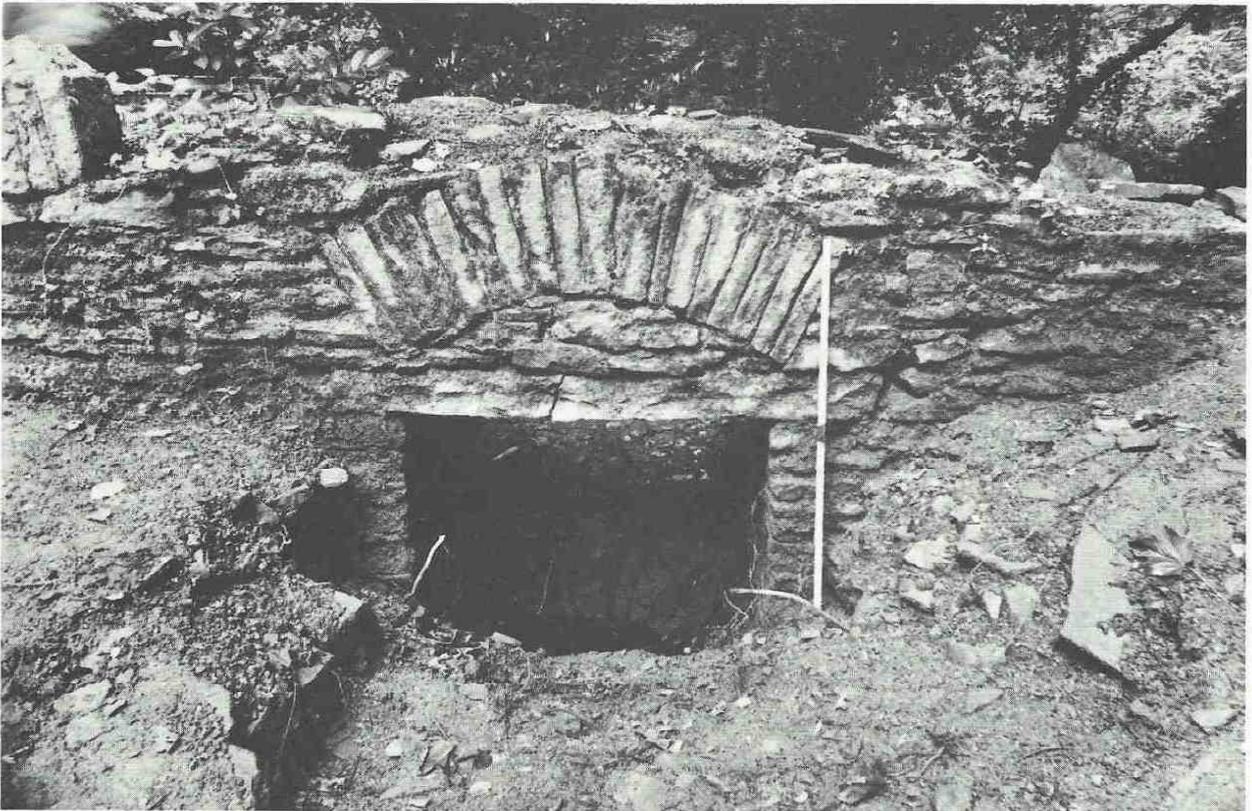
KING'S MILL The archway seen from inside the mill during the current excavations, with the bridge visible through it. The scale is a metre ruler. (Photo: John Cornwell)

2. The Arch way

This lies across the water course, and has been dug out almost to the level of the wheel pit; outside it is a crude but solid arched bridge over the tail race, apparently earlier than anything else we have so far found.
