THE SOMERSET COAL CANAL

a Cartographical Survey

Mike Chapman

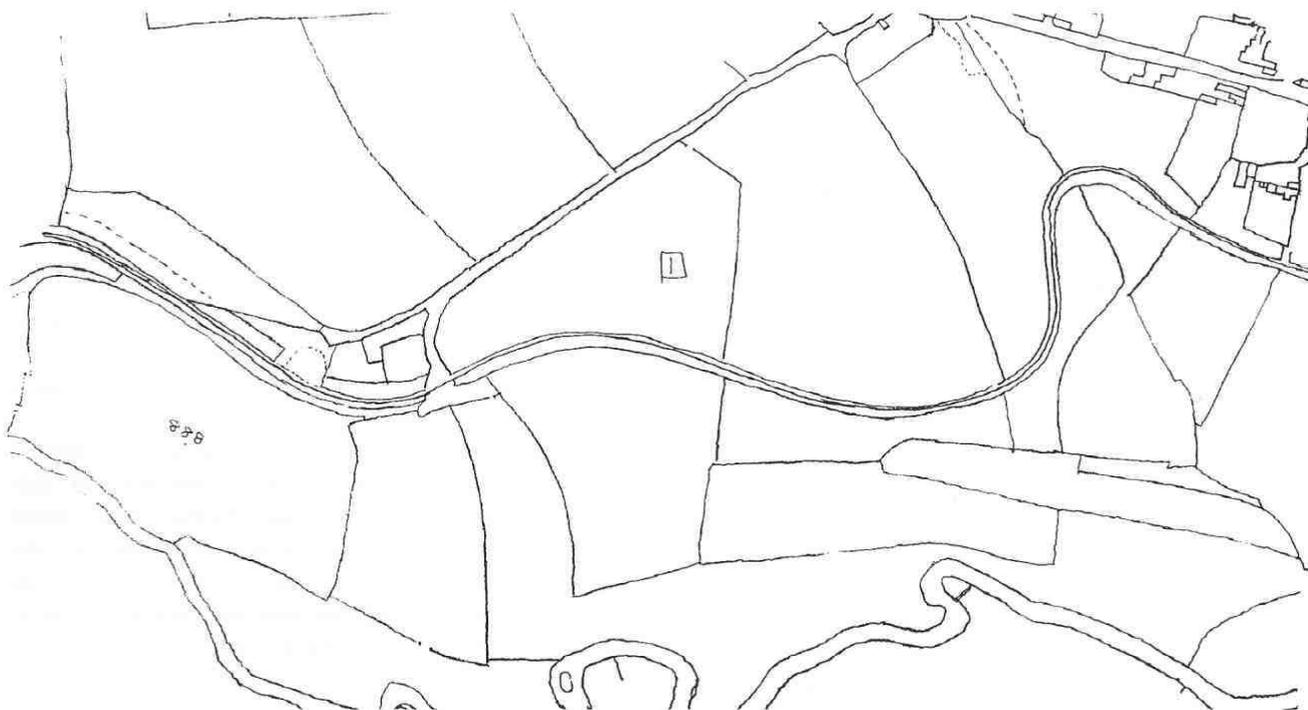
Wellow Parish Tithe Map, 1840.

2) Parish Tithe Maps ; particularly useful on the Radstock Line of the canal with the tramway along the towpath in operation, and this is shown clearly over most of its course on the Wellow map. It was unusual to include such detail on a Tithe map and it is possible that

the surveyor in this instance used it as a base line to chain out to intermediate features. Even the passing loops are accurately represented. In the seven miles between the Radstock Terminus and Midford Wharf there were 23 loops, mostly 60 or 70 yards long.

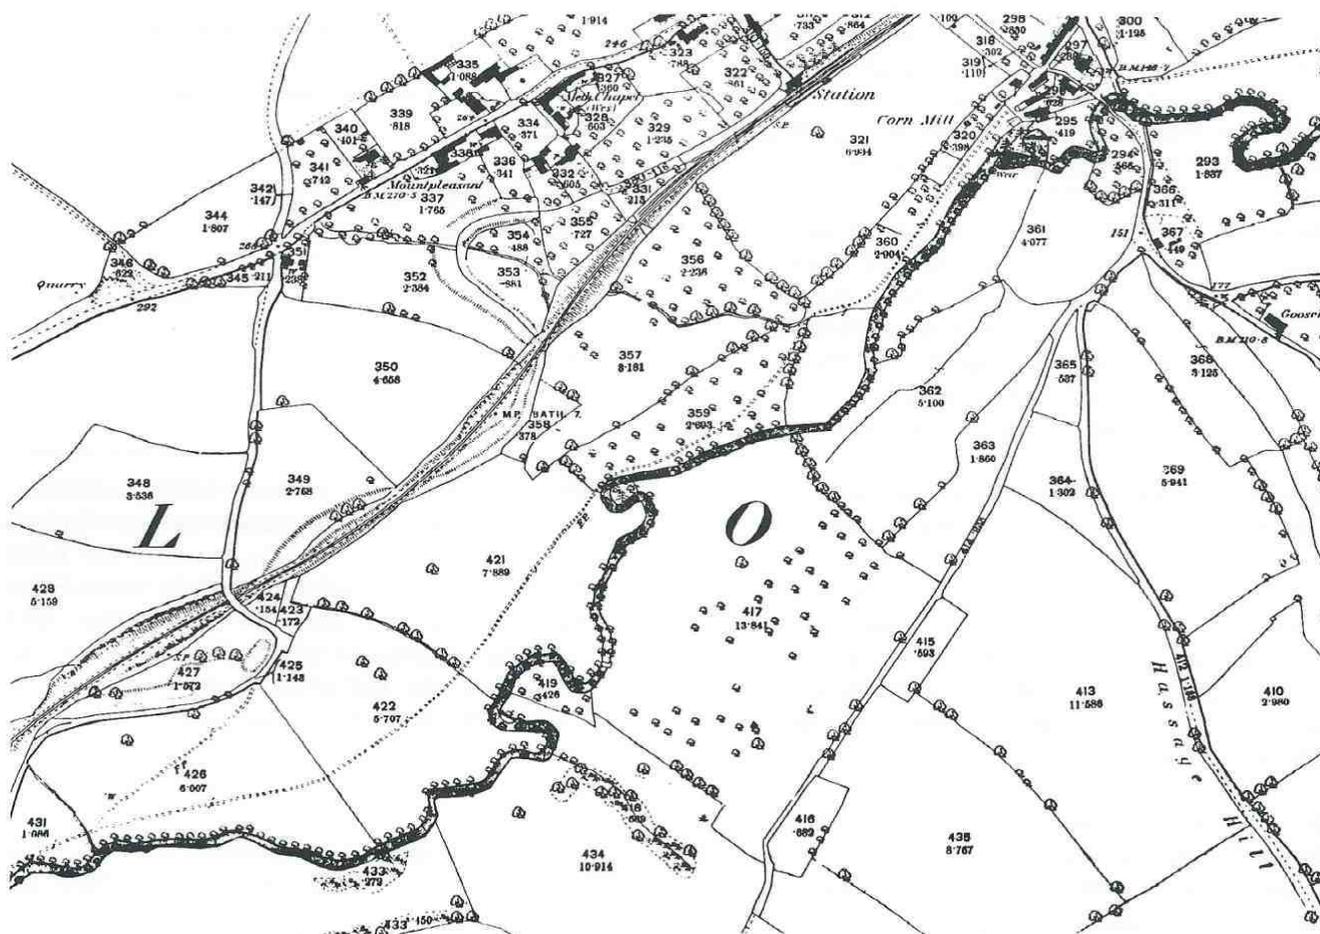
Same area - O.S. Map 1/2500 Scale, First Edition, Surveyed 1884.

Details of the canal, including adjacent features within a few hundred yards of either side, were transferred from the 1884 O.S. sheets onto current O.S. 1/2500 base maps by photocopying and simple back-light tracing, making due adjustment for paper stretch and other factors. By using a photocopier with digital enlarger the same technique was used for the Tithe maps and despite an expected loss of accuracy a tolerable fit could still be obtained with a degree of error acceptable for the purposes of this survey. Even the Radstock Line could be represented by interpolating the banks of the canal between the towpath tramway and the canal boundaries.

In this way several radical and unsuspected alterations to the landscape came to light, and information shown on the earliest maps could be easily identified and transferred to the base map by eye. The base map was also annotated with useful data derived from early photographs and documentary sources. From hereon the survey was carried on in the field to compare the base map with findings on the ground.

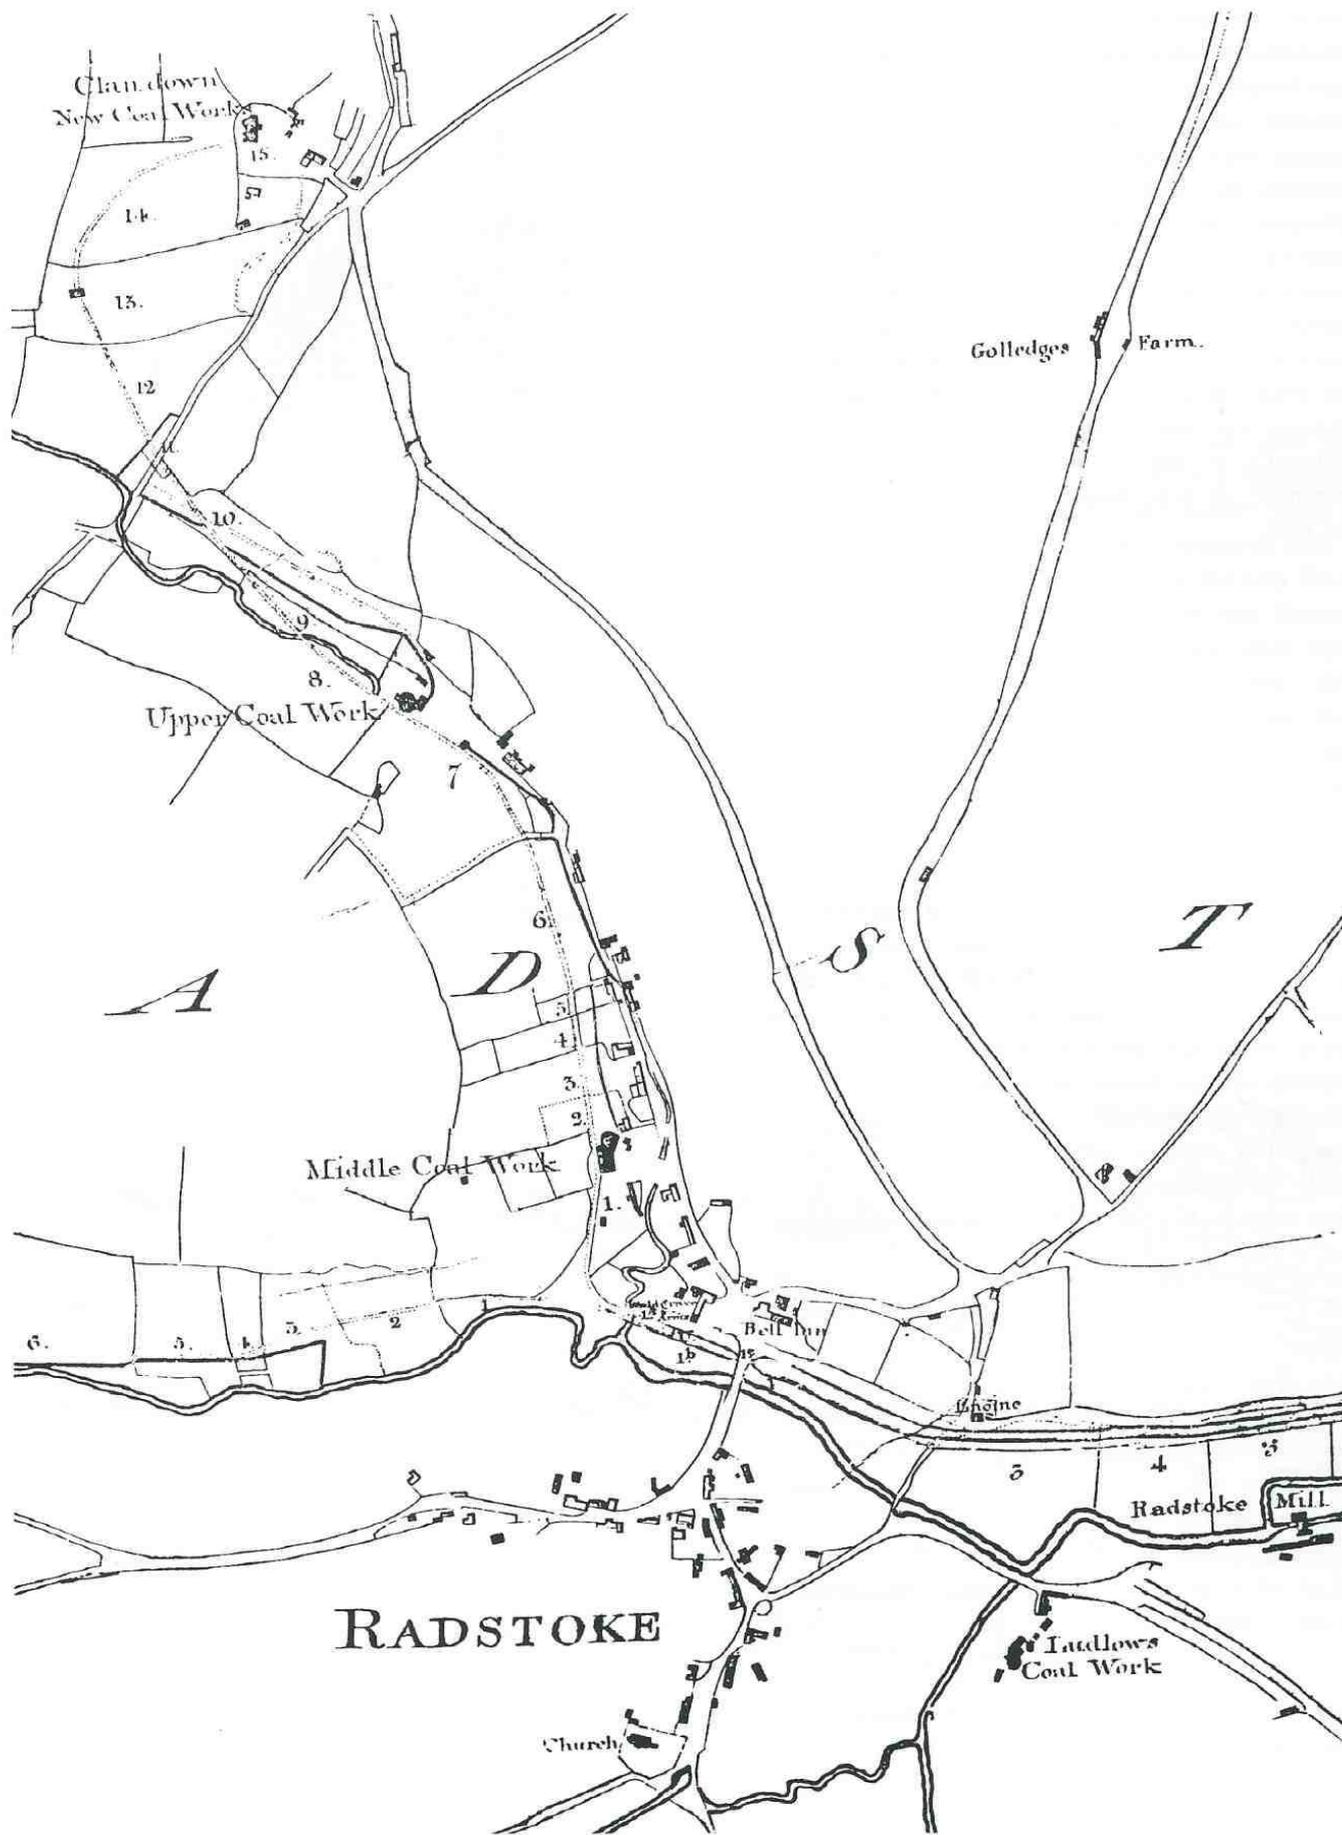
Canal Terminus at Radstock, Cruse Map - circa 1807.

A similar system may have operated at the Radstock terminus. Both the Waldegrave map and the Cruse map show a long cut following the Wellow Brook from the Fosseway Bridge and stopping several hundred yards short of the canal basin. It may have continued by culvert to the canal over the stream from Clandown. The canal was originally planned to extend beyond Radstock to terminate at Welton, thereby following the same course as this cut. The terminus has been buried by later railway construction but remains further upstream could come to light; many remains have been found of another leat that once fed the Radstock Collieries from the Clandown stream.

The terminus at Radstock is no longer visible, but the Waldegrave map shows that it had an unusual layout of end-on docking bays separated by tramroad jetties. Part of the bed was revealed during excavations for the road to Midsomer Norton in 1924 (Somerset Guardian 7th Aug.1925)

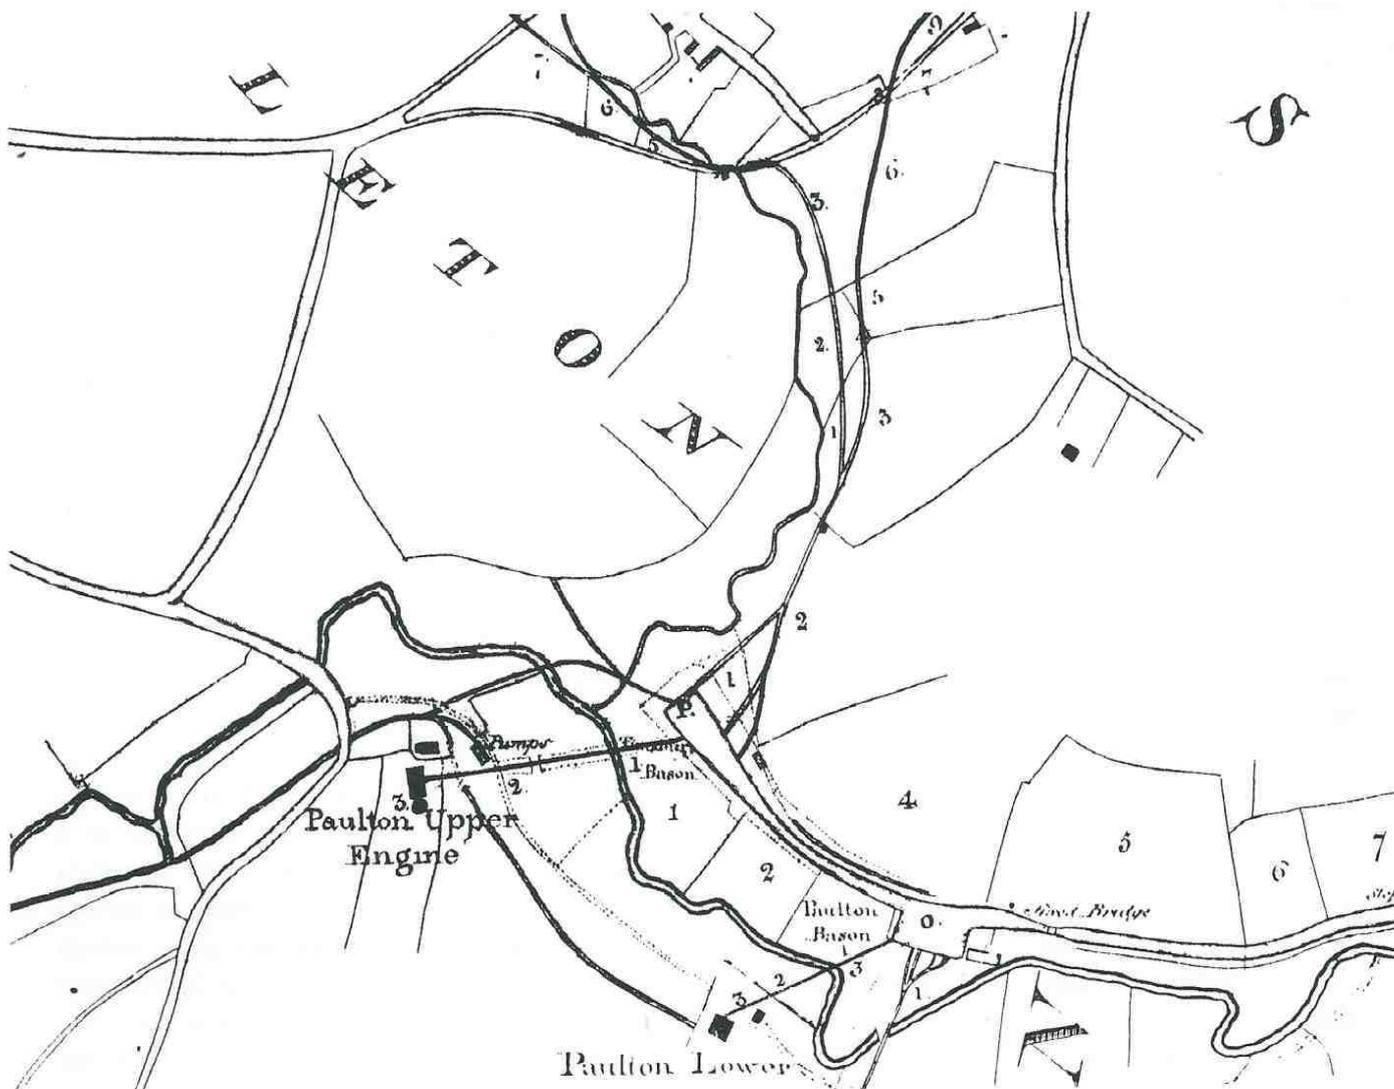
Main Canal Terminus at Timsbury, Cruse Map - circa 1807.

The Cruse Map shows that the canal terminus at Timsbury was originally supplied from Cam Brook by a complicated set of leats, evidently originally cut to supply the boilers of both Paulton Upper and Lower Engine Pits with clean water (Pit water being too contaminated for the purpose) The canal supply leat is shown crossing back over the Cam and another smaller brook to join the terminal basin via a sluice. Whether these crossings were made by small aqueducts or launders is not shown, but may be surmised in order to achieve the necessary height. The Tithe maps do not show this area in great detail and by the time of the 1884 O.S. map this part of the canal had already fallen into disuse, as had the last of the local collieries - Paulton (lower) Engine. Incidentally the map on page 60 of Down and Warrington's 'History of the Somerset Coalfield' is incorrect in transposing

the two Paulton Engine pits. Although the Sewage works and extensive tipping in this area have obliterated most surface features, the point of entry into the basin is still clear and there is a prominent abutment in the south bank of the Brook at the crossing site. The remains of the sluice-keeper/wharfinger's cottage have only disappeared very recently.

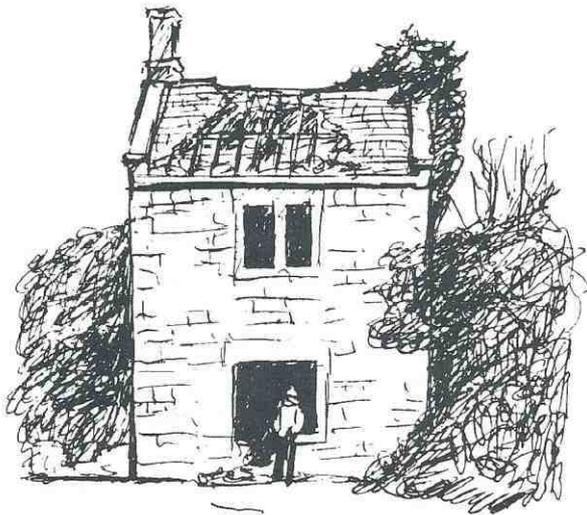
Timsbury Wharfinger's Cottage in 1975.

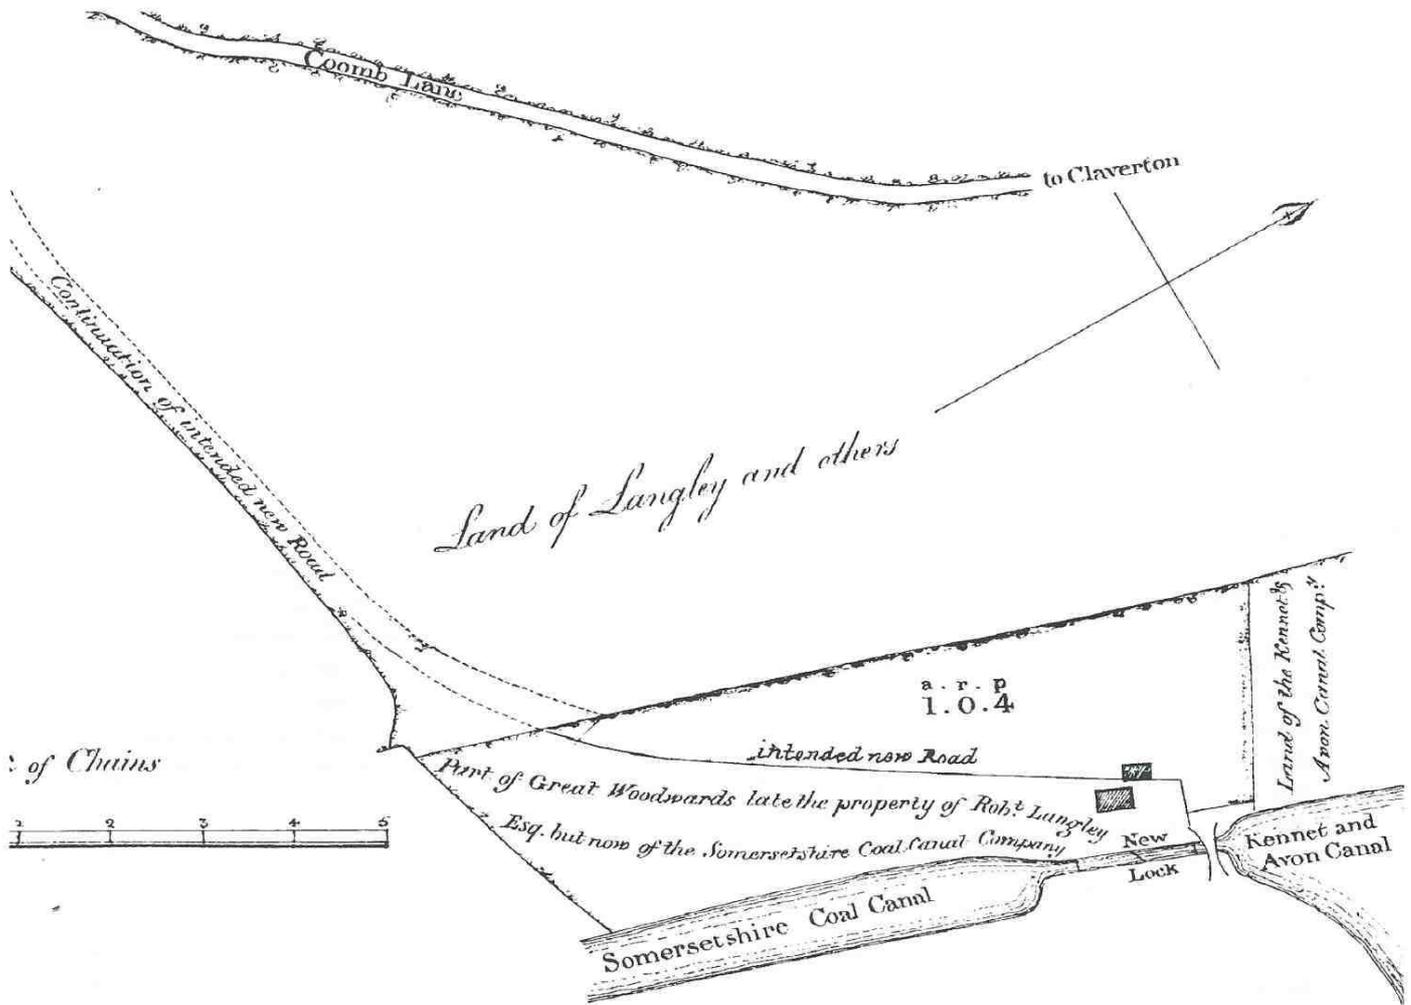
Dundas Junction, as shown on an Agreement dated 1823 between SCC and Kennet & Avon Canal Company to jointly build a road.

Lock at Dundas which was modified from a wider pattern and has a somewhat different design (Hammond p29). It has only a slight drop, the Enabling Act of 1794 stipulating that the 'canal be so made as to communicate with the Kennet and Avon Canal on a dead level' (Fuller p2273). In practice the Kennet and Avon Company insisted on a higher level being maintained so as not to lose any of their valuable water they were having to pump from the Avon at Claverton.

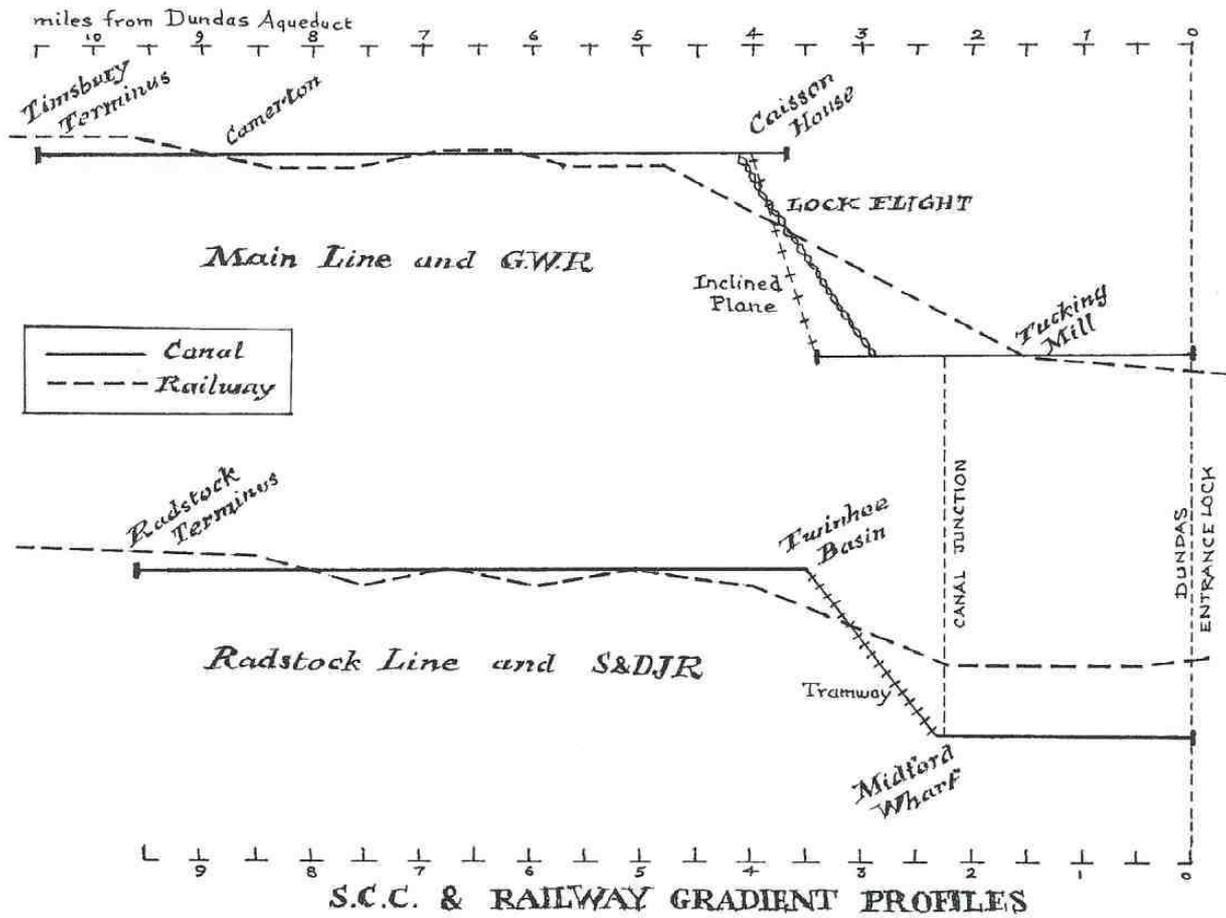
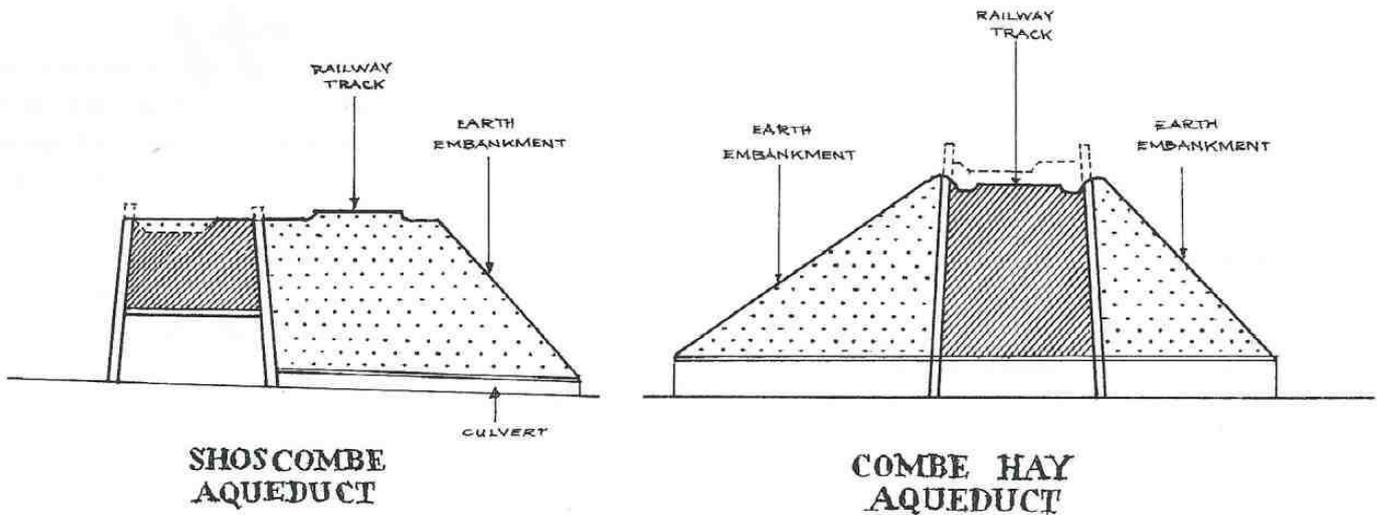
Somerset Coal Canal - Profiles

Whereas the Canal was constructed on two levels connected by the Lock flight, the Railway from Camerton to Limpley Stoke, built on it in 1905, was laid to a steady gradient so that between Tucking Mill and the Lock flight summit it was too high above the canal to follow the same course. Most of this section, about 2½ miles, has therefore also survived and the towpath similarly provides a public footpath.

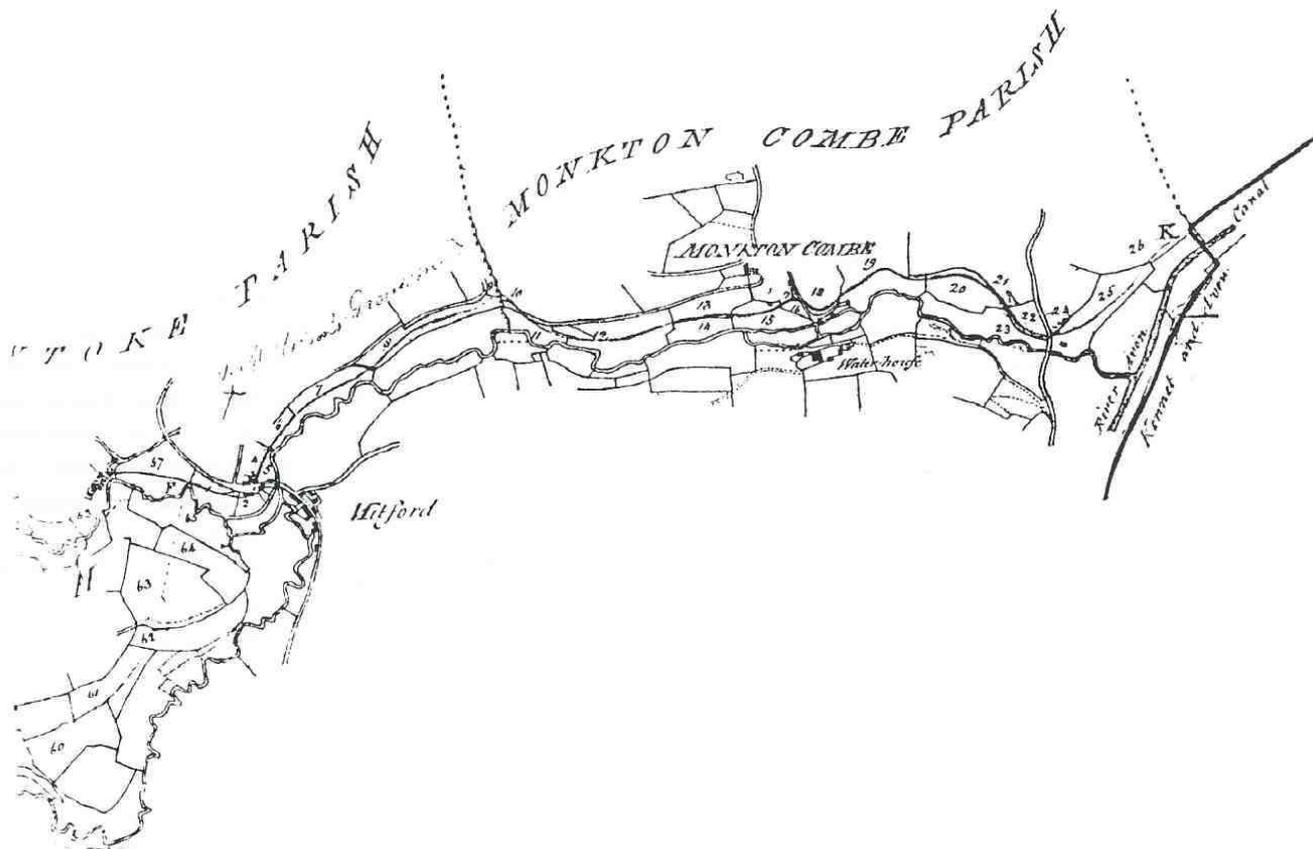
Somerset Coal Canal, Deviations Plan, 1795.

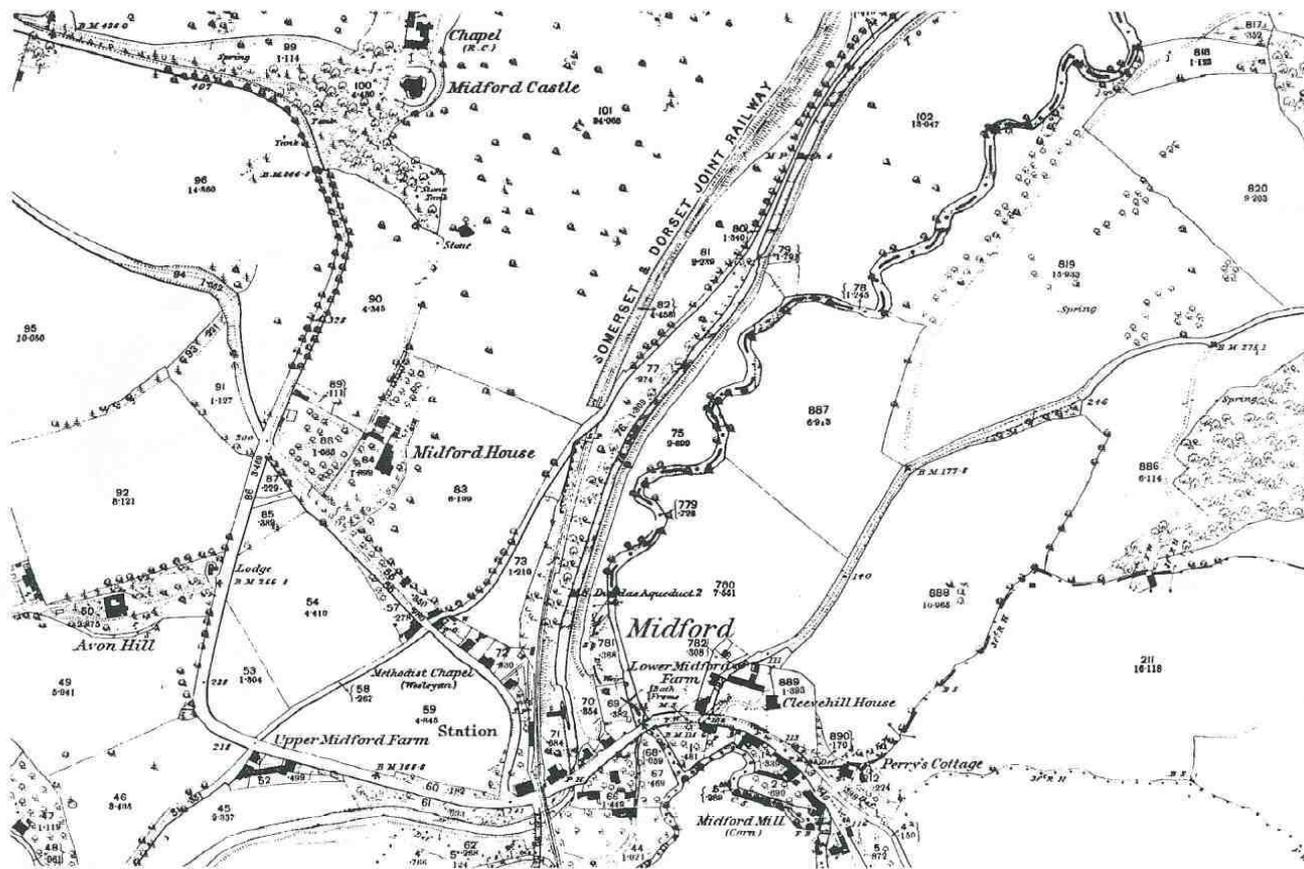
Ordnance Survey Map, Midford Area, 1/2500 Scale, First Edition, Surveyed 1884.

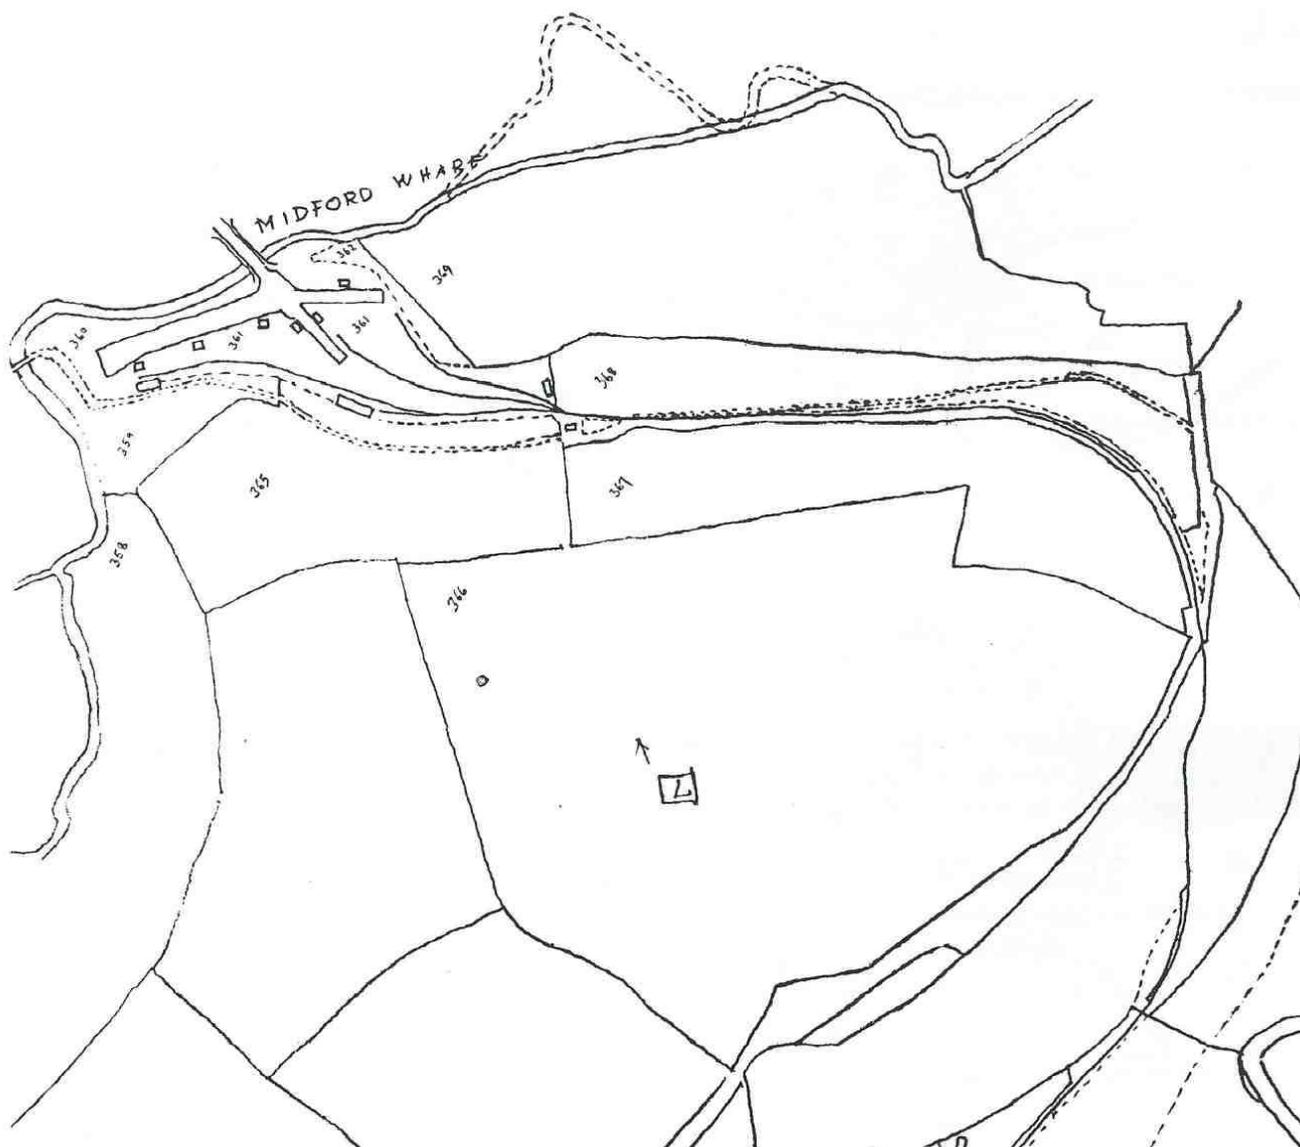
Wellow Parish Tithe Map, Midford Wharf, 1840

Built to carry the Radstock Line of the canal over the Cam Brook and to form a junction with the Main Line, this aqueduct was exceptional, and although quite small, was something of a 'showpiece'. Unlike the others, which appear to all have been made with rubble masonry, Midford was faced entirely with Bath Stone Ashlar and its neat three-arched design is conspicuous even in its present dilapidated condition. Had the original plans for the canal been fulfilled it would have presented a charming approach to a flight of locks instead of its active life as entry to a rather grubby trans-shipment coal wharf - time and nature have since restored its dignity .

can be traced but did not see much activity during the 14 years of its working life. Quite the opposite was true at Midford Wharf which was provided with three large docking areas branching out from the aqueduct. These have since been filled in but can be seen as depressions in the grass. Thanks to recent pipelaying through the Cam Valley some of the topsoil of the wharf was removed, revealing a bewildering array of tramroad sleeper blocks. These indicate a complicated web of sidings and turnouts which tends to confirm the suspicion that traffic was extremely congested prior to the sale of the Radstock Line to the S&D Railway. The official S&D figures for tonnage carried on the tramway were no doubt exaggerated (Clew p104) but even the revised figure would still require the unloading of 23 trains, of 8-9 waggons, per day.

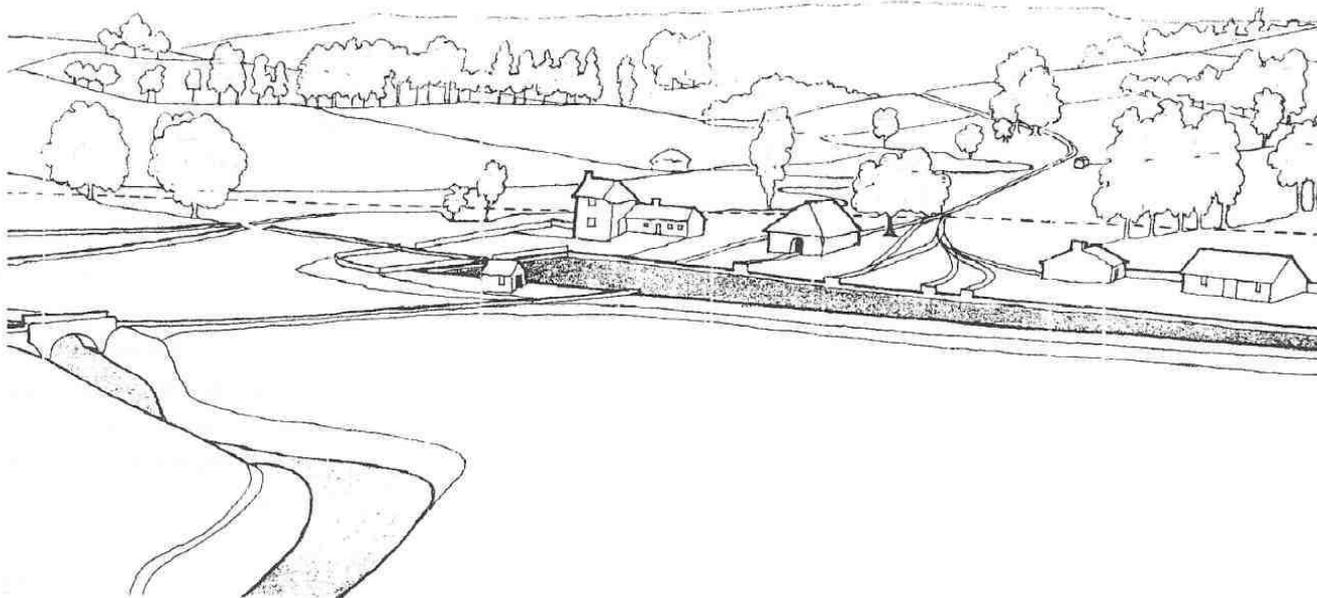
Timsbury Basin in 1872 (from an old photograph)

Except at Wells Road and Dundas all the wharves had some form of tramroad connection. A recently discovered photograph (Clew p102) of Timsbury Basin in the 1870's gives a good impression of the layout typical of the larger coal wharves. Much of the retaining walls of the Paulton and Timsbury Basins can still be seen, but all the buildings have disappeared except for a few ruined foundations on the Paulton side.

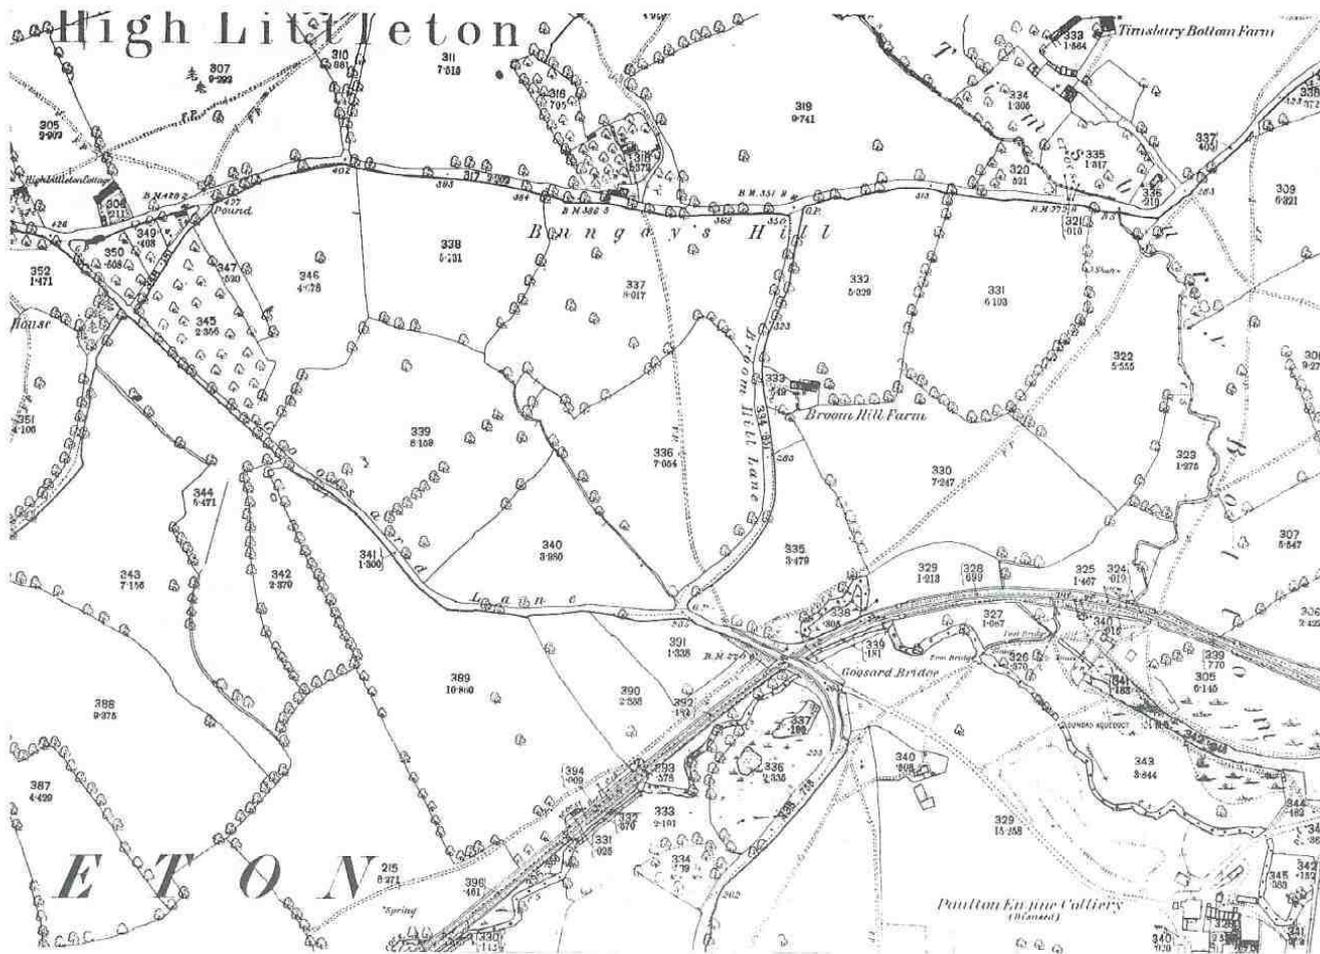
Timsbury Terminus in 1884 - O.S. Map 1/2500, First Edition.

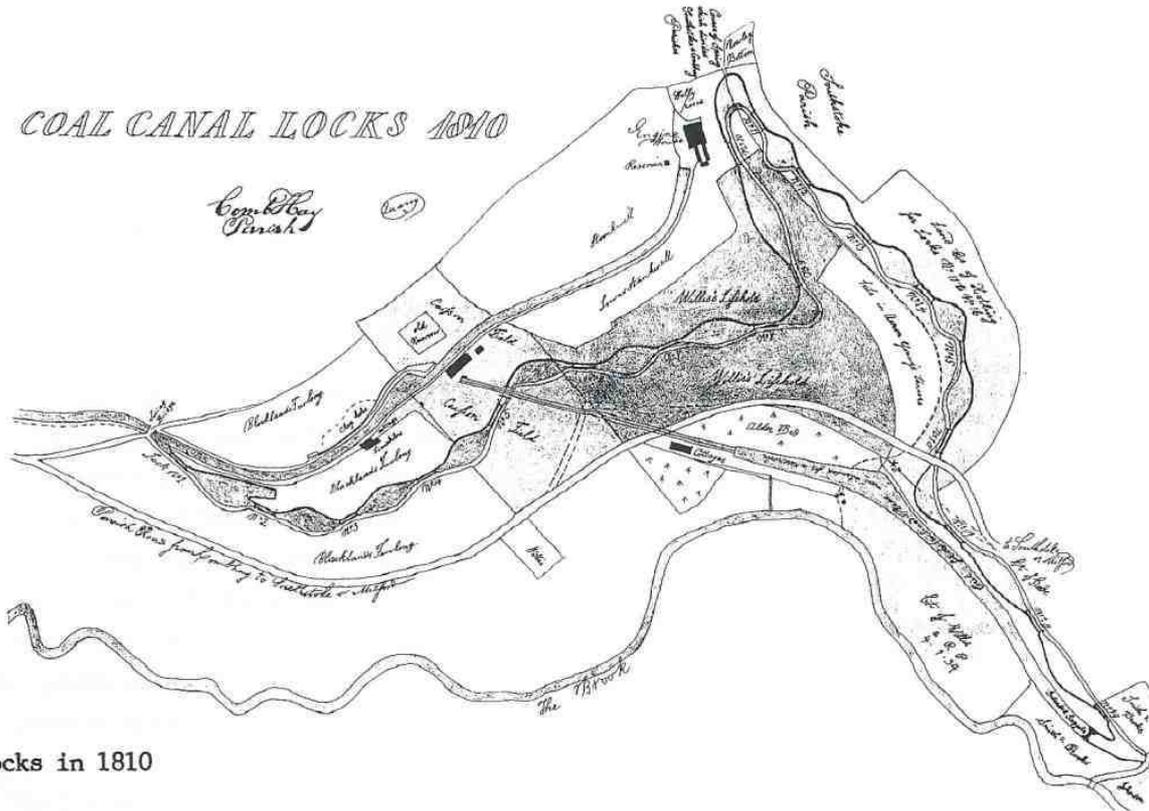
Combe Hay Locks in 1810

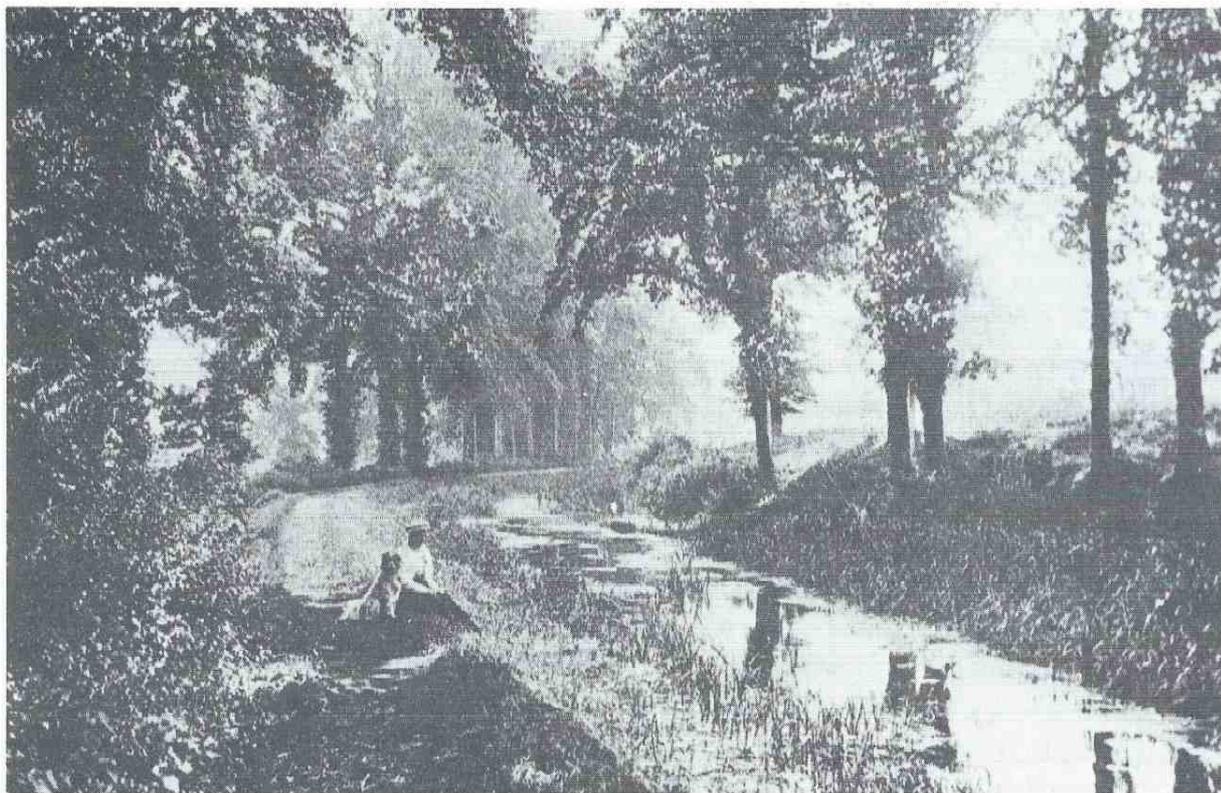
Somerset Coal Canal at Timsbury, circa 1900.
