Our cover illustrations

Survey of unknown date of the condition of Cleveland Bridge, Bath, apparently prepared for the repair and strengthening of the bridge in the 1920s. The surveyor reported, *inter alia*:

BIAS

JOURNAL 27

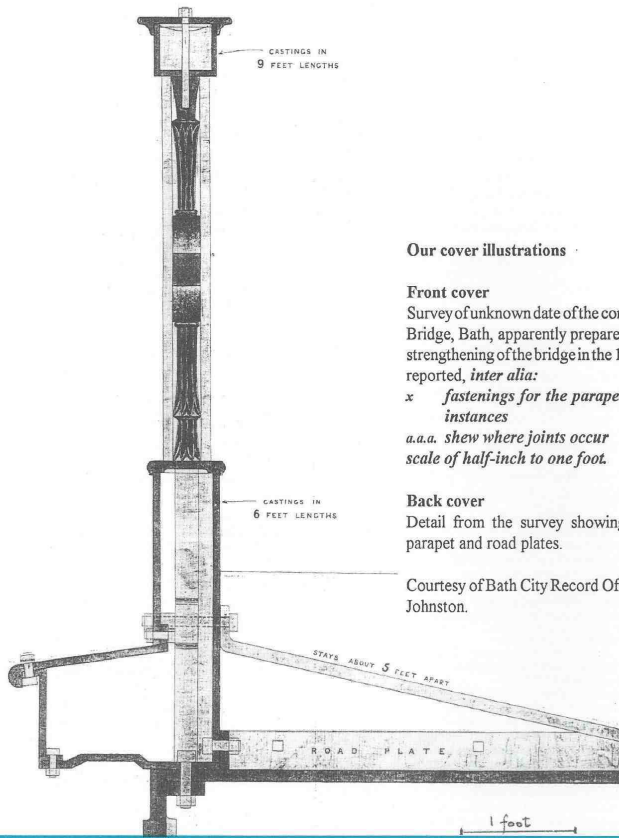
Front cover

x fastenings for the parapet, broken in many instances

a.a.a. shew where joints occur
scale of half-inch to one foot.

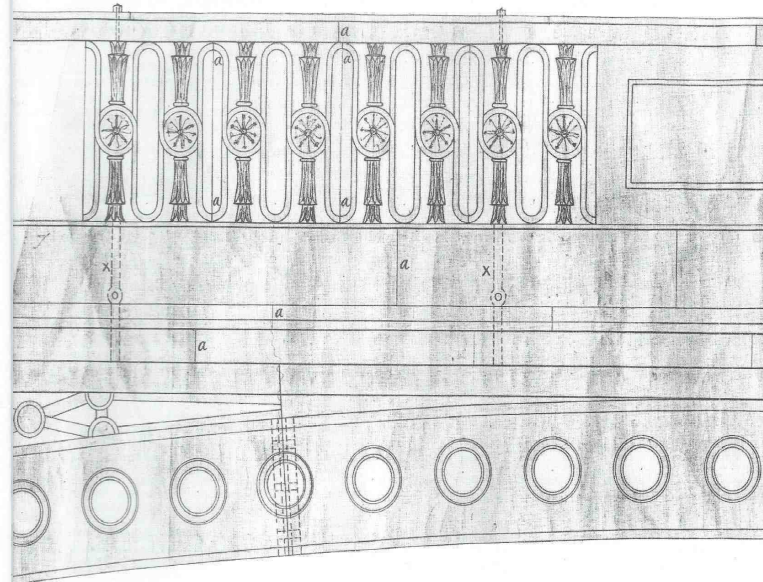
Back cover

Detail from the survey showing a section of the parapet and road plates.
