A Trial Excavation of the Suspected Site of the Caisson Lock, Combe Hay, 1997

Mike Chapman

The Trial Excavation

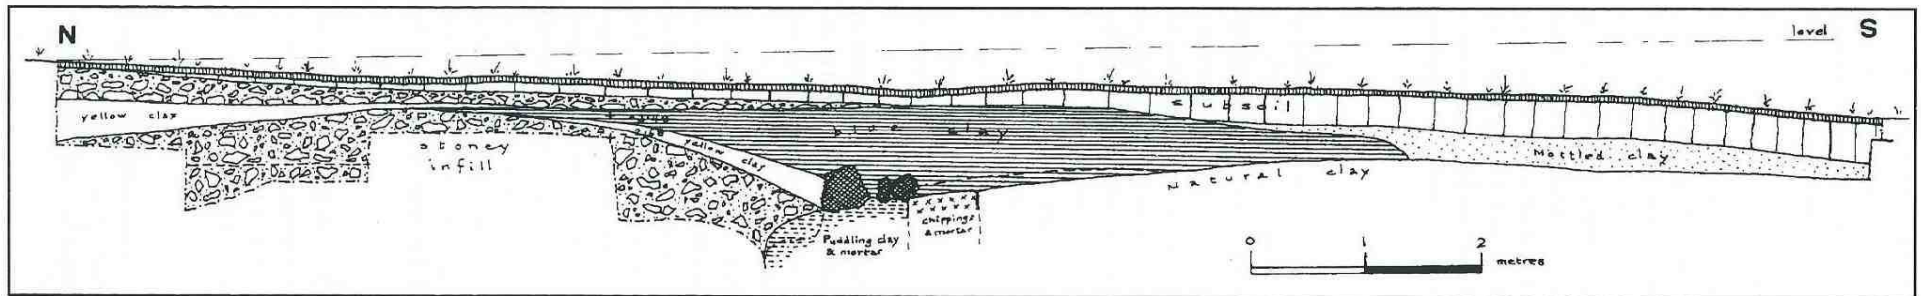
Archaeological section along the lower (east) side of the trench.

Some 12 ft further on, approaching the northern end of the trench, the blue clay increased in thickness to just below turf level. Immediately below the clay at this point, showing through the earlier ground surface, a band of packed chippings and mortar about 2 ft in width and vertically edged was found crossing the trench on an east-west axis. Unfortunately this band was not detected until a late stage owing to a number of large unworked stones and boulders which lay on top of it, and a detailed examination was not possible in the time available. However, although quantities of blue clay - mixed with lumps of mortar - occurred for a further 4 ft, it became evident that the band of chippings actually marked the southern edge of a deep excavation containing a massive infill of rubble and stoney clay. The depth of this infill could not be ascertained, although it was followed downward a further 2 ft below the earlier ground surface to a maximum depth of 5 ft below present ground level.

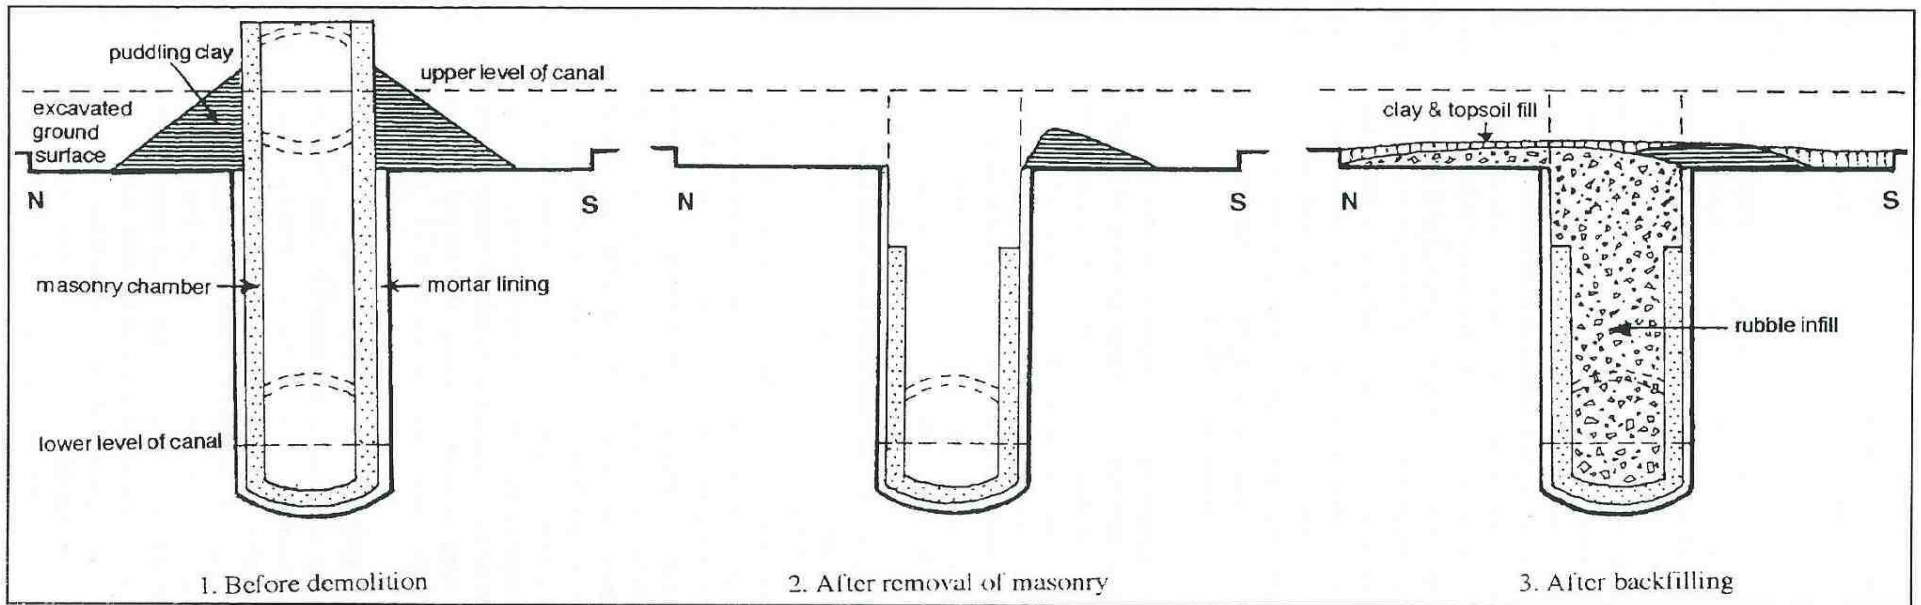
Suggested sequence of demolition and infill of the Caisson Lock.

Although such a large (and apparently deep) backfilled excavation was to be expected on the site of the Caisson as indicated on the canal map, the only structural element found was the band of mortar and chippings at its southern edge. This however is a feature that might be expected in association with dismantled masonry (supporting the opinion that much of the stone lining of the upper part of the lock chamber had been removed), and would represent the bedding for the masonry walls of the chamber against the sides of the excavated lock pit. Cer-

tainly the amount of blue puddling clay lying outside it (extending about 12 ft from the side) would have been sufficient to provide the basis of the waterproof embankment (or 'angle of repose') needed to support the superstructure of the lock.

The presence of so much ironwork in the puddling clay still requires explanation, but the finding of the half-penny in this material suggests that the site was backfilled in 1807 or soon after - in agreement with the map evidence. The new map shows that the abandoned Caisson was apparently still open when the lock flight and pump were installed early in 1805, but had disappeared by the time of the next datable maps of the lock flight. c1809. The rubble infill was barren of human artifacts and was presumably construction material excavated from elsewhere along the canal.

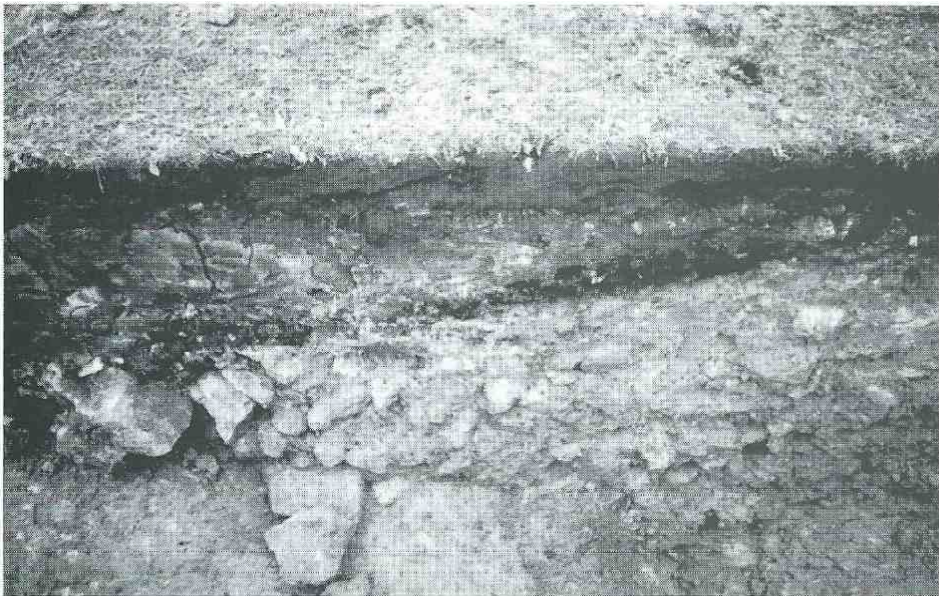
Photo: Roger Halse.

View of the trench section (upper, west side) showing the layer of puddling clay overlaying the rubble infill, separated by a thin band of coal waste. The band of chippings and mortar was found crossing the bottom of the trench below the large stones to the left. The rubble infill continued on downward to the right.

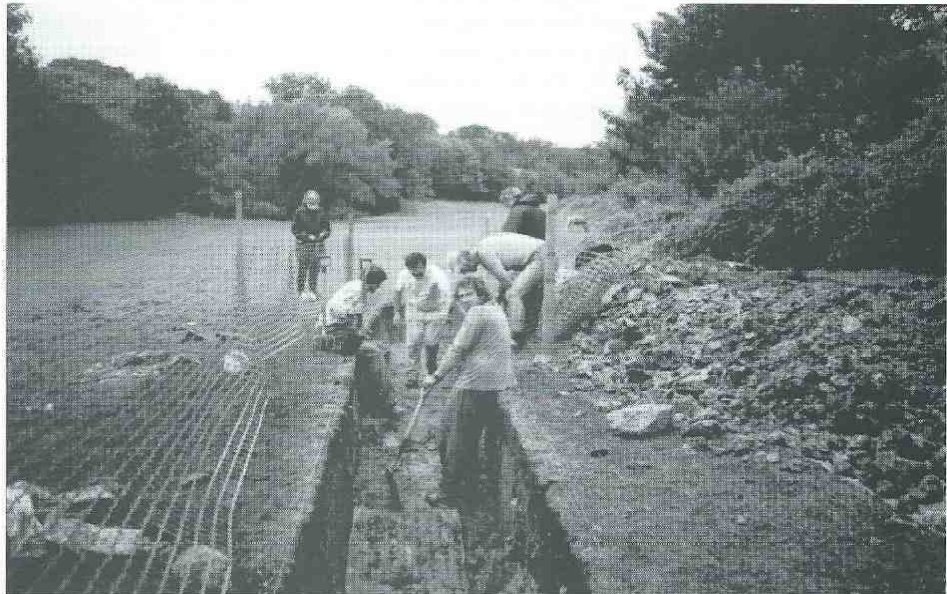
Photo: Roger Halse.

The southern end of the trench at the early stages of the excavation. The lock flight is hidden among the trees in the background. Behind the bushes to the right is the workshop adjoining the upper basin of the canal.

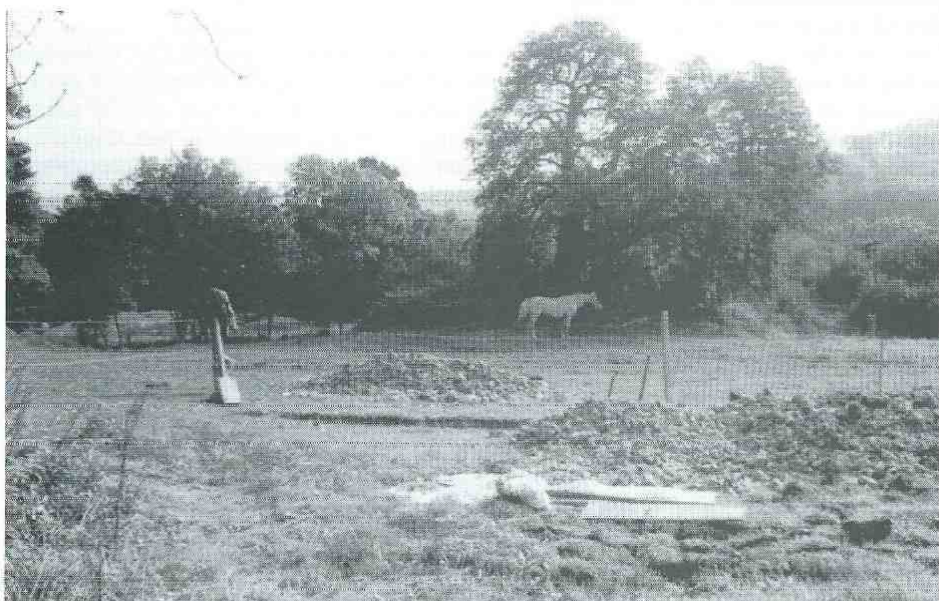
Photo: Mike Chapman.

View taken along the line of the Caisson, looking east. The northern end of the trench is visible in the foreground, the chestnut tree beyond. To the left of the tree lock 5 is just visible.
