## Emergency Recording of the Malthouse at Clearbrook Farm, Midford Hill

Sheila Ely

The malthouse was recorded in 1996 as part of the statutory Emergency Recording work undertaken by the Royal Commission on the Historical Monuments of England, prior to the conversion of the building into residential accommodation. The jack-arched first floor was in a state of collapse at the time of survey.

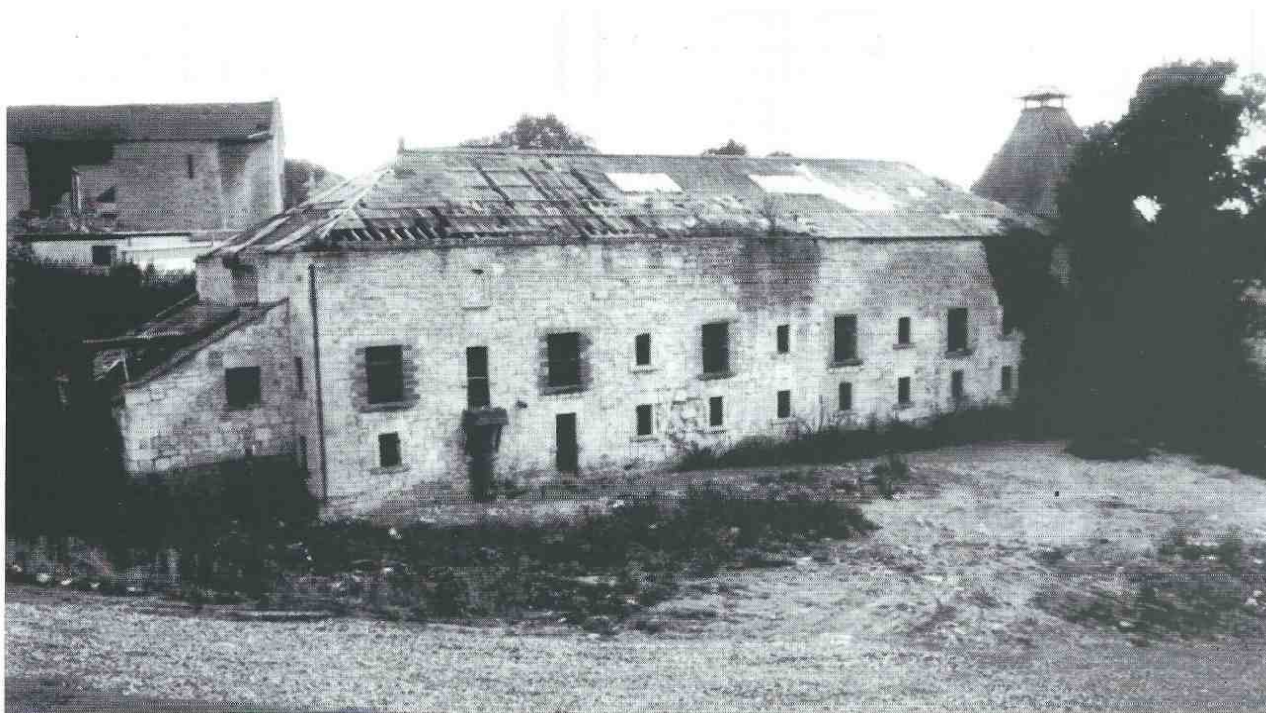
The Malthouse, North elevation

Each bay on the northern side of the growing floors was lit by a small unglazed rectangular window at ground and first-floor level. Each window had iron security bars on its outer face and a simple side-hung ledged timber shutter with strap hinges, set inside the line of the security bars. Three similar windows opened onto a small yard or area, cut into the higher ground on the southern side of the building. One shutter survived at the time of survey. The large number of small shuttered windows in the northern elevation clearly indicates that the ground and first floors were growing floors. The shuttered windows would have been used to control the temperature and humidity on these floors. There was a single taking-in door at first-floor level at the western end of the north front. This door was presumably for loading malt direct from the kiln onto carts. The top floor of the growing-floor range had only two windows in each of the long elevations. Additional natural light was provided to this floor by large areas of roof lighting which remained *in situ*. The lack of windows to provide ventilation indicates that this floor was used for storage.

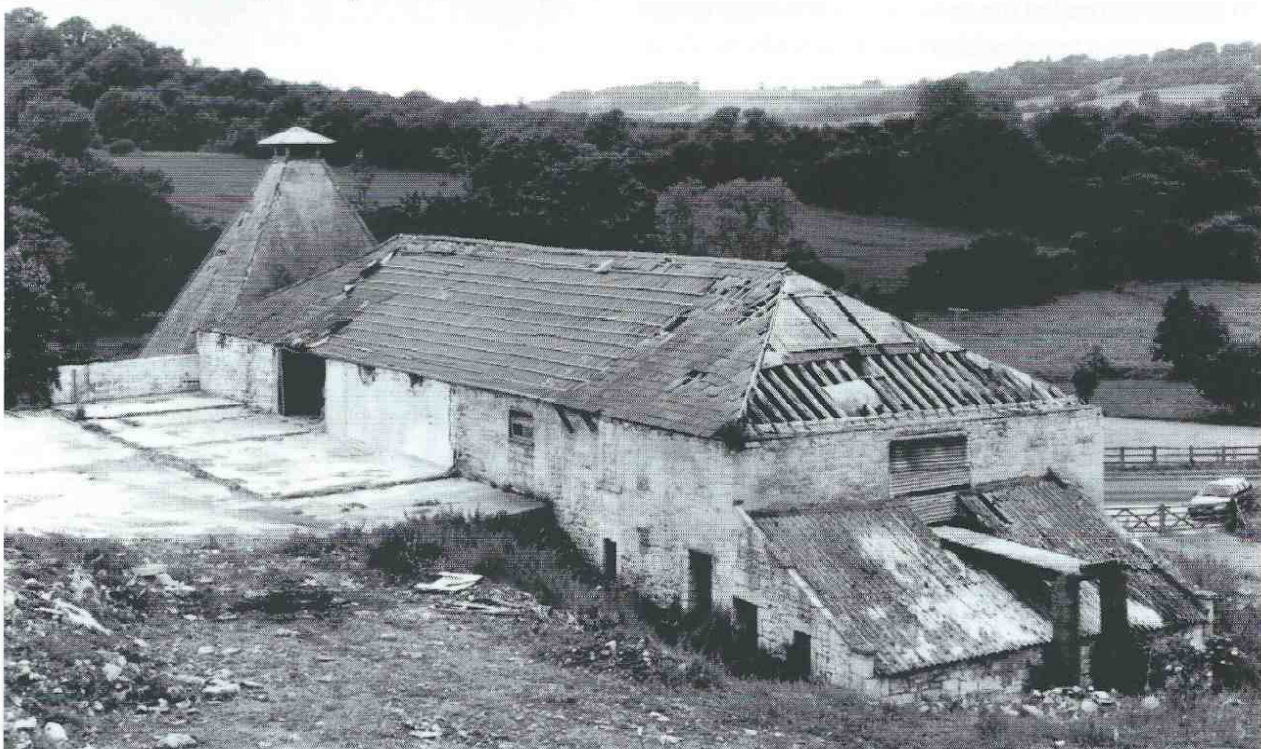
97/1362 BB97/14463 Crown copyright RCHM(E)

General view of Malthouse, view from SE

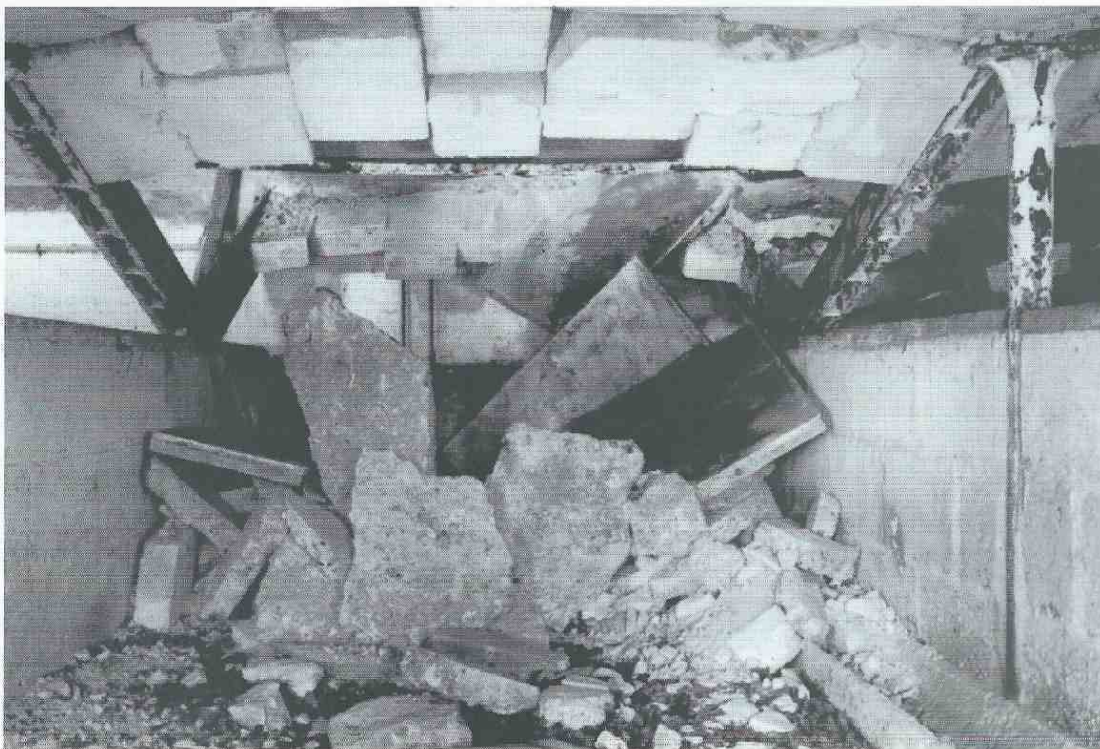
96/2255 BB96/10269 Crown copyright RCHM(E)

Ground floor, principal range, collapsed stone jack-archway

The first floor was supported by shallow jack-arching which was constructed from dressed limestone blocks measuring 100mm in depth. The jack-arching was supported by 'triangular'-section cast-iron beams and cast-iron columns. The jack-arching was strengthened by square-section tie bars which ran the length of the growing-floor range. The cast-iron beams measured *circa* 4.20m in length, two lengths spanning the building. The beams were 'triangular' in section but had compartmented recesses in the soffit. Each recess measured about 360mm in length. The beam ends broadened just before the point at

which they were set into the wall but were of constant height in long section. The way in which the beams linked with the columns at ground and first-floor levels was not visible at the time of survey. Cast-iron beams of this sectional form are not common. The jack-arching supported a lime and rubble screed which probably originally had a plaster surface, but is now covered with a cement screed.
