Excavation and Conservation works at The Golden Valley Colliery, Bitton

John Cornwell I

BIAS JOURNAL No 23 1990

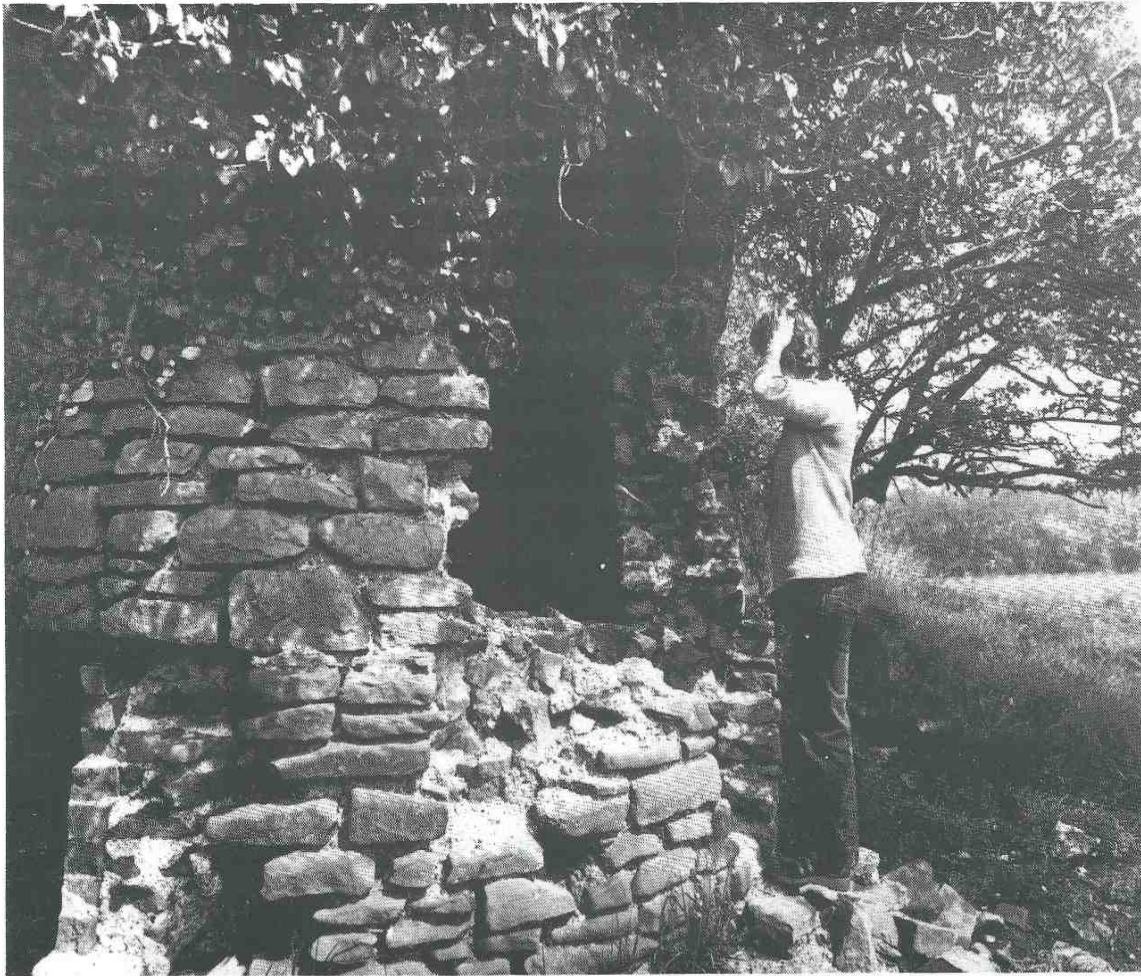
It also revealed just how perilous a condition the chimney was in, with the lintel of the furnace charging hole literally supported on one end by ivy boughs and very little else. A cast iron trampoline acting as lintel to the ashpit access hole on the far side of the chimney was also cracked in half giving little or no support.

Doreen Martin, inspecting the Furnace in 1982

Hydraulic Pit Props to avoid immediate calamity, then removing stone from the base of the hole to reach a secure foundation on which to rebuild; then rebuilding the top of the internal by-pass flue at the same time as filling in the hole; only progressively removing ivy boughs to keep its support to the last possible moment.

New bricks were brought in to rebuild the missing side pier to support the charging hole lintel, ensuring that all the new work we put in could in future be readily identified from the old. With the aid of the hydraulic pit props the chimney was raised sufficiently to re-bed the lintel to its proper level; and then to replace the broken lintel on the far side with a suitable length of steel railway line.

The day came when we could tackle the major task of removing the ivy from the top two-thirds of the chimney - now well dead having been left over winter with severed roots. On the Week-end of 13 May 1984, tower scaffolding was hired (funded by BIAS) and a grand 'ivy pulling' was enjoyed by the normal 3-4 workforce, specially augmented for the occasion by BIAS members and others. Apart from bending one of the lightweight scaffolding poles, all went well

leaving the chimney naked and proud, ready for the job of rebuilding the top 4 courses of brickwork, plus the raking out and total repointing of the structure.

This work necessitated long term hire of scaffolding - at that time well beyond our means - and we did what we could in the meantime by filling in cracks accessible by ladder, placed both outside and inside the chimney shaft.

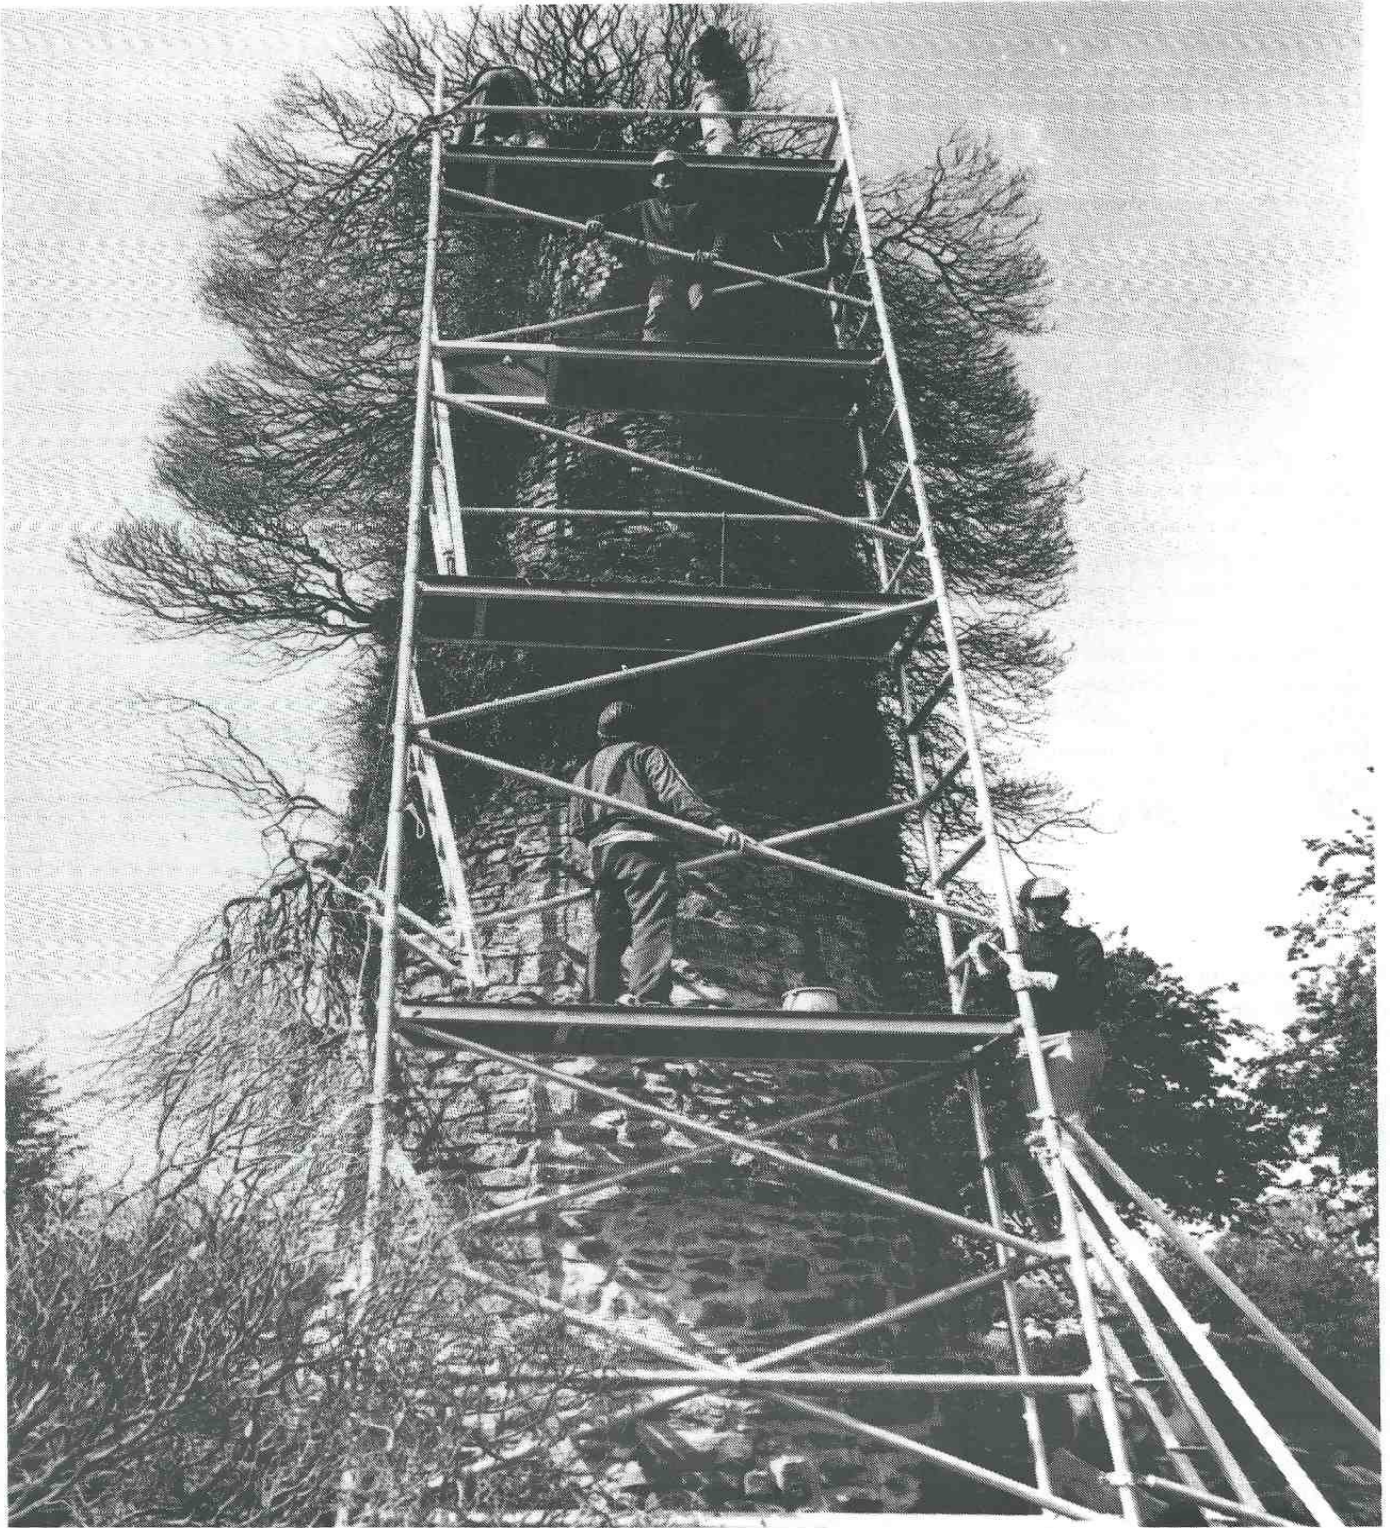
De-ivying the Furnace Chimney, May 1984

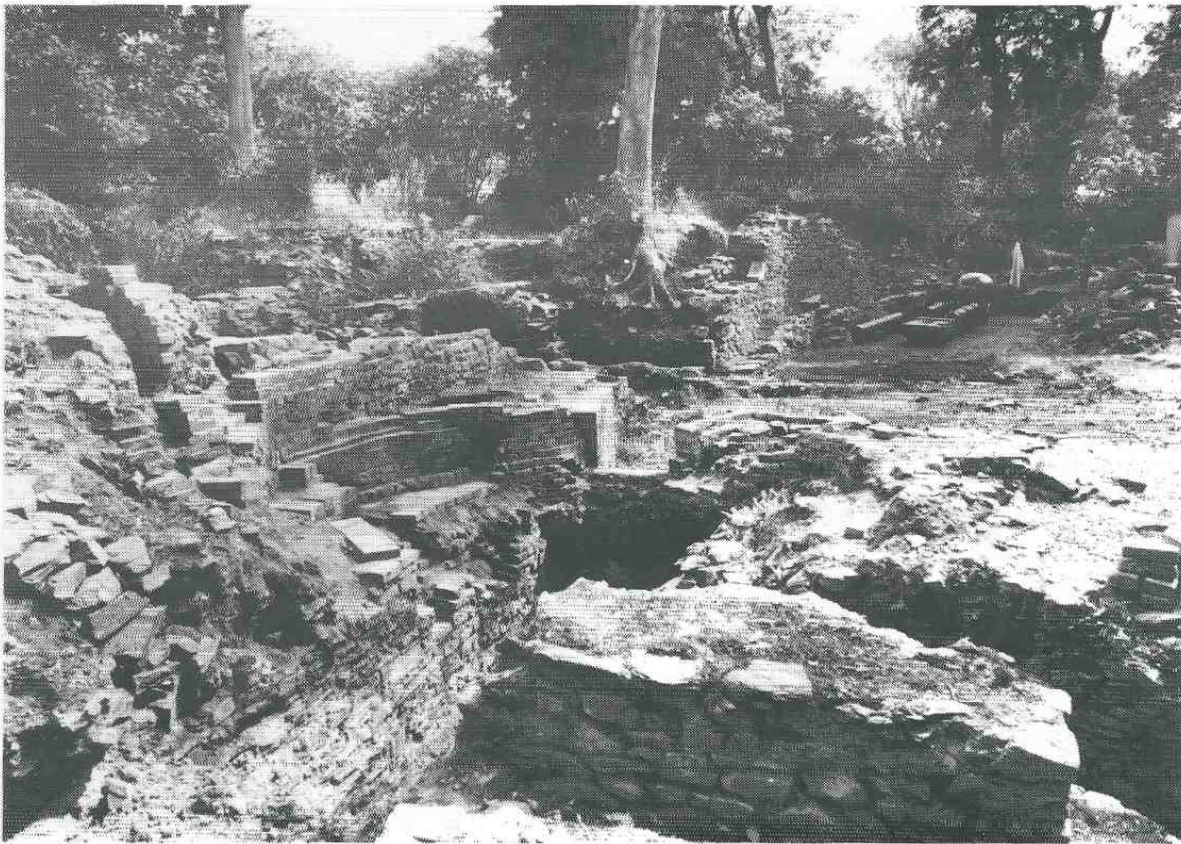
view of Old Pit site looking South from the rear of the Haystack boiler setting.

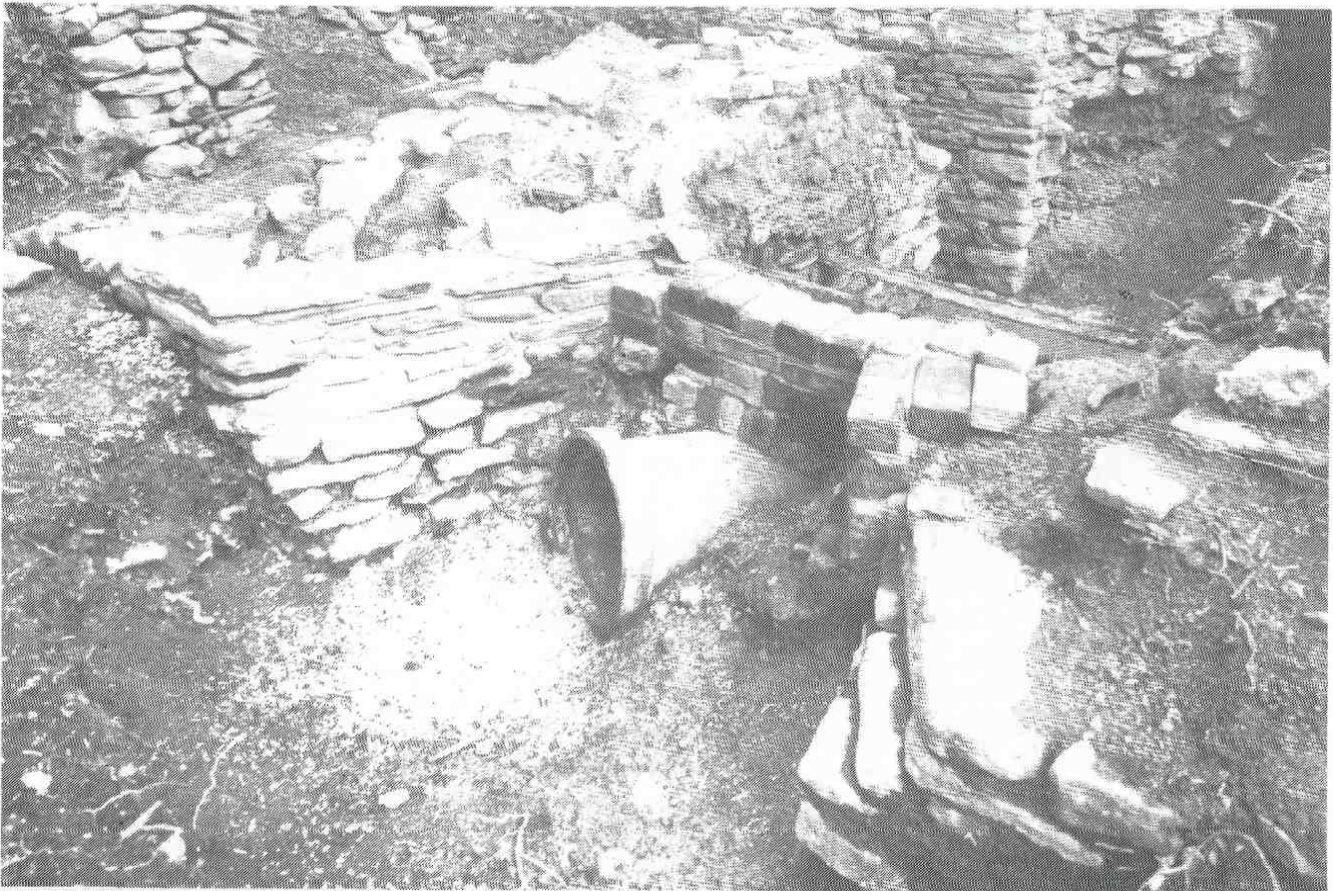
Egg Ended boiler setting, note large pipe for additional draught.

built against the western side of the pumping house. Eventually the setting for a large haystack boiler, 14 feet in diameter, and for a small egg-ended boiler, 16 feet long and approximately 6½ feet in diameter, was uncovered.

Almost all the of the original boiler setting was constructed from pennant sandstone, only the firebox and flues were built in firebrick. In later repairs common brick was used, even the sections of the firebox were later constructed from ordinary bricks, which were supplied by the Cattybrook Brick Company. Very few marked firebricks have been found on the site. Where these are imprinted they are mostly of a Staffordshire manufacturer that cannot be closely dated (Rufford' and 'Hickman'). One or two of 'crowned' B imprint were found which may have come from the Brain fireclay works at Crews Hole.

As work on the boilers proceeded, it soon became apparent that the brickwork of the flues and boiler settings was in a very unsound condition. The fire-bars had been removed and the lintels which supported the fire-bars had been torn from the brickwork of the fire box, leaving large holes. Most of the brickwork above the back of
